NORTHERN CORRIDOR TRANSIT AND  
TRANSPORT COORDINATION AUTHORITY

# REPORT ON BLACK SPOTS SURVEY ALONG THE NORTHERN CORRIDOR ROUTES IN RWANDA AND UGANDA

20 March 2020

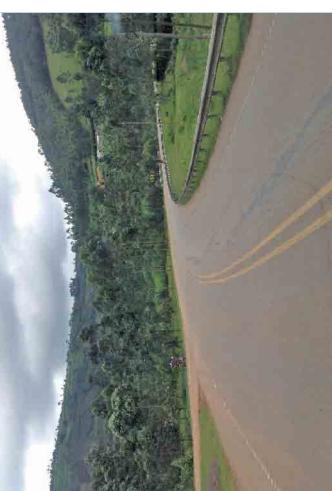
<p><i>Dangerous combination of horizontal and vertical curves merging at a trading centre</i></p>	<ul style="list-style-type: none"> <li>Vehicles/ drivers mainly heavy goods vehicles from Kabaale to Katuna fail to negotiate the sharp curve/ corner at the shopping Centre leading to pedestrian deaths.</li> <li>The sharp curve/ corner is in a built-up area.</li> </ul>	<ul style="list-style-type: none"> <li>Provision of a designated pedestrian crossing facility</li> <li>Installation of enhanced road signage to limit approach speeds and warn motorists of the dangerous sharp curve</li> <li>Enhanced road user sensitization and enforcement of safety by relevant agencies</li> <li>Installation of speed cameras to monitor travel speeds</li> <li>Provision of off-road truck run away ramps/sand arrester beds for vehicles that veer off at the curve</li> <li>Provision of streetlights to illuminate the area at night</li> <li>Designation of shopping spot off the road at a safe distance away from the road to decongest the road area</li> </ul>

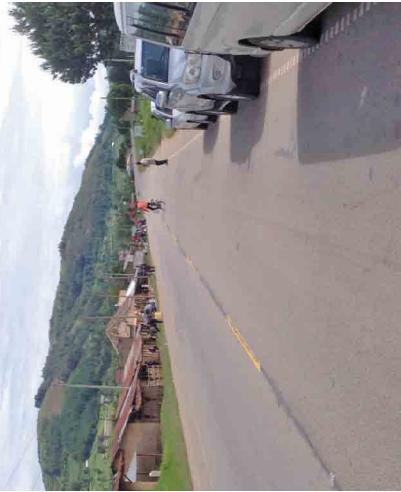
*Relatively built up area along a straight stretch with significant cross road movements*

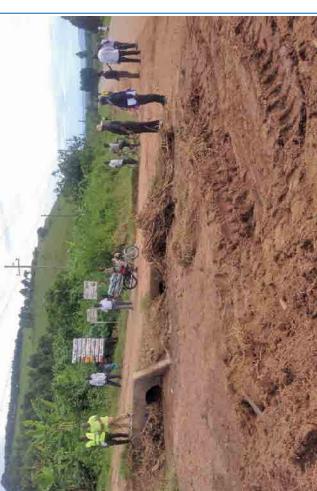
<ul style="list-style-type: none"> <li>Narrow Side road junction joined to the blind sharp curve</li> <li>Lack of enough waiting space for the vehicles joining the highway</li> <li>Insufficient turning radius at the junction hence turning vehicles occupy outer lanes causing side swipe collisions</li> </ul>	<ul style="list-style-type: none"> <li>Medium and heavy goods vehicles mainly carrying agricultural produce tend to overturn while descending towards the junction</li> </ul>	<ul style="list-style-type: none"> <li>Enhance road signage at the junction i.e Give Way/Stop signage from the access road and Junction Ahead signs on the main highway</li> <li>Enhance driver sensitization and training to encourage safe road user behaviour</li> <li>Re-designing and improvement of the junction to provide for adequate turning radii and speed change (acceleration and deceleration) lanes</li> <li>Clearing of vegetation and establishments near the junction to increase visibility spans</li> </ul>

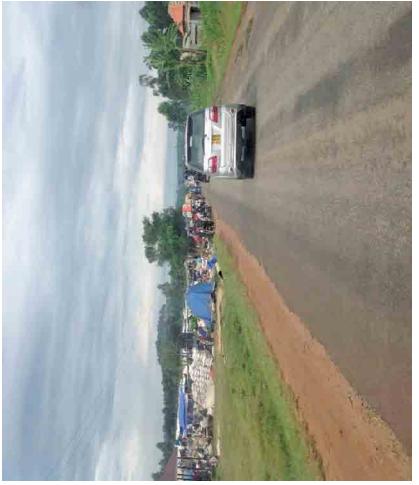
<p><i>Market vendors have encroached into the road reserve. No designated crossing points are in place along the stretch</i></p>	<ul style="list-style-type: none"> <li>Accidents mainly involve pedestrians and people chasing grasshoppers ending up on the road</li> <li>Accidents mainly attributable to reckless driving/ overspeeding and pedestrians accessing the live carriage way heedless of traffic</li> </ul>	<ul style="list-style-type: none"> <li>Provision of appropriate road signs</li> <li>Installation of speed humps and rumble strips to lower approach speeds to the market centre</li> <li>Provision of designated pedestrian crossings for safe cross road movements (raised pedestrian crossings/table tops are more desirable as they also act as speed calming measures)</li> <li>Application of retro-reflective road marking on the road and installation of delineator road studs</li> <li>Relocation of the market beyond the road reserve</li> <li>Develop a policy for all developments along the roads</li> </ul>

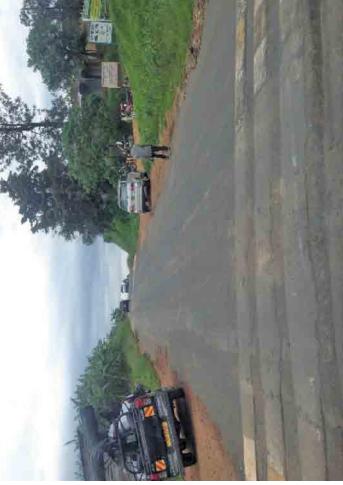
<ul style="list-style-type: none"> <li>Accidents are mainly caused by over speeding, reckless driving and failure of heavy trucks to ascend steep horizontal alignment</li> <li>Slowly climbing heavy trucks block the road leading to unwarranted overtaking by small vehicles, causing head-on or single accidents</li> </ul>	<ul style="list-style-type: none"> <li>Provide appropriate road signs (speed limit and sharp curve ahead signage)</li> <li>Improve on the existing humps</li> <li>Repair of the deteriorated edges and application of appropriate road marking</li> <li>Enhance road user sensitization and driver training</li> <li>Widen the road to provide for a climbing lane</li> <li>Review the geometric design to reduce the crest and sag curves</li> <li>Redesign the side road junction to provide adequate turning radius including acceleration and deceleration lanes</li> <li>Consider installation of speed cameras as long term mitigation measure</li> </ul>

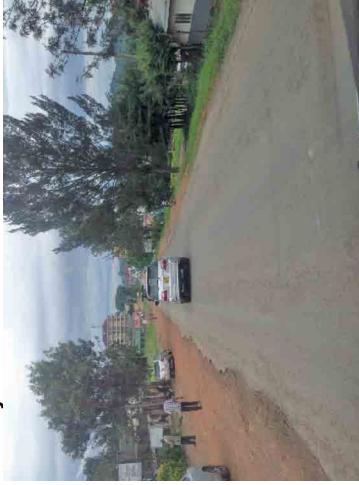
<ul style="list-style-type: none"> <li>Absence of parking facilities and narrowed carriageway leads to frequent accidents</li> </ul>	<ul style="list-style-type: none"> <li>Provision of parking facilities and expansion of carriageway to provide enough space for traffic maneuverability</li> <li>Rehabilitation and widening of the carriageway to at least 3.5m lane widths</li> </ul>

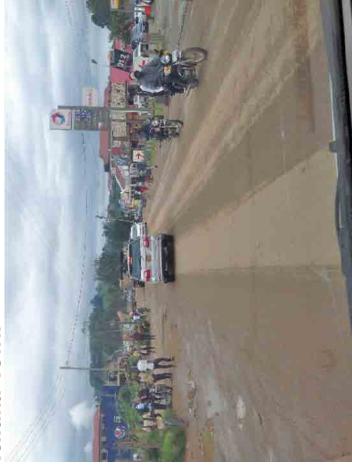
<ul style="list-style-type: none"> <li>Narrow carriageway causes opposing traffic to collide or brush their bodies</li> <li>Unregulated motorcycle activities leads to frequent accidents involving the motorcyclists and highway traffic</li> </ul>	<ul style="list-style-type: none"> <li>Rehabilitation and expanding of the carriageway to provide ample space for motorists maneuver</li> <li>Provision of designated parking for the motorcyclists and other Public Service Traffic</li> <li>Since the road is under rehabilitation, there is need to look at the design and find out how safety was considered mostly on: <ul style="list-style-type: none"> <li>NMT and pedestrian crossing facilities</li> <li>Junction design improvement (i.e. consider staggering the accesses at the junction and channelizing the intersection)</li> <li>Provision of parking facilities for both motorcyclists and PSVs and service lanes with controlled access to the main road</li> </ul> </li> <li>Enhance sensitization to all road users and enforcement of safe road user behaviour</li> <li>Enhanced temporary work zone signage and control of traffic to avert any possible incidents</li> </ul>

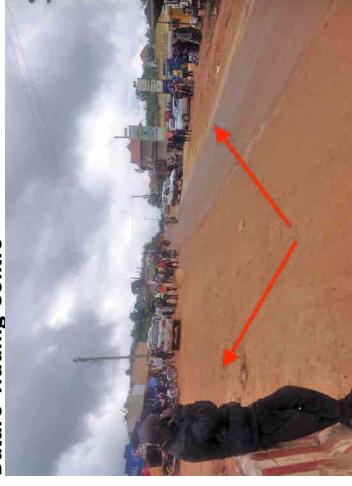
<p><i>Cross junction at the road which is already under construction is responsible for side impact crashes</i></p>

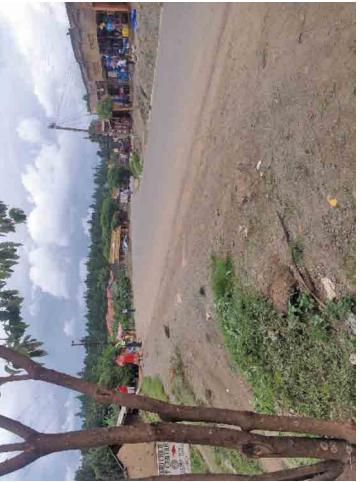
<p><i>Extremely sharp curve at the market centre with no provision for safety fences on high embankment</i></p>	<ul style="list-style-type: none"> <li>The stretch traverses a hilly to mountainous terrain with successive combinations of horizontal and vertical curves</li> <li>Provide appropriate road signs along the stretch(speed limit and sharp curve ahead warning signs)</li> <li>Provide pedestrian crossing facilities for safe cross road movements within the market</li> <li>Installation of safety fences (flex beam guardrails with reflective studs) and directional arrow (chevron) signs at the tight curves</li> <li>Enhance sensitization to all road users and enforcement of safety</li> <li>Review the design to consider: <ul style="list-style-type: none"> <li>- Lane separation with central medians</li> <li>- Speed calming humps and rumble strips to the descending lane</li> <li>- Provision of climbing lanes</li> <li>- Redesign the RHS side junction to provide adequate turning radius and speed change (acceleration and deceleration) lanes</li> </ul> </li> </ul>

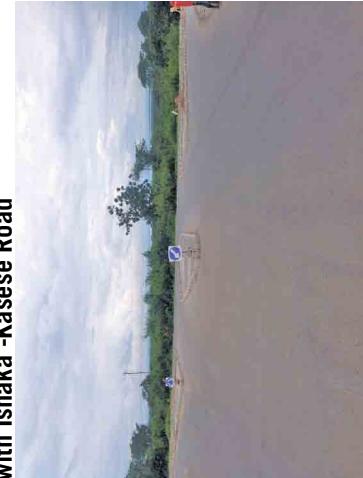
<ul style="list-style-type: none"> <li>The recently completed T-junction has been channelized for safe passage of traffic</li> </ul>	<ul style="list-style-type: none"> <li>Provide appropriate road signs (speed limit signs on the approach to the T-Junction, Stop and Give Way signs)</li> <li>Limit the speed towards the junction in the form of speed calming rumble strips</li> <li>Application of retro-reflective road marking on the recently completed junction</li> </ul>

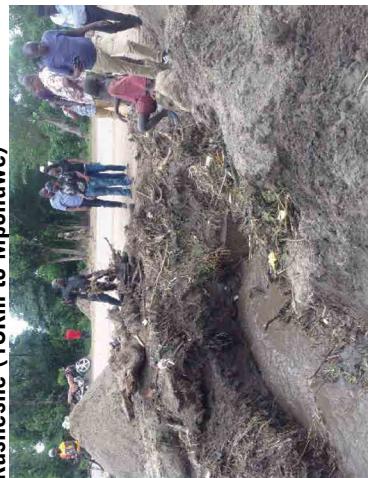
<p><i>Unclogging of the access culvert due to blockage by debris and tree stumps from the upstream</i></p>	<ul style="list-style-type: none"> <li>Vehicles don't cross the road at this point during heavy rains due to flash floods</li> </ul>	<ul style="list-style-type: none"> <li>Sand mining should be stopped/relocated immediately</li> <li>Desilt the cross culvert and the river inlet and outlet drain</li> <li>Ensure routine maintenance is carried out</li> <li>Enhance sensitization and enforcement of safety works</li> <li>Carry out "River Training" works</li> </ul>

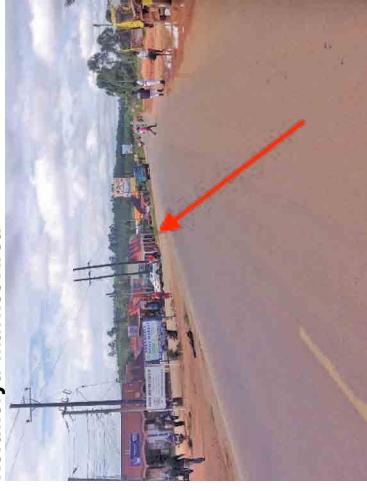
<ul style="list-style-type: none"> <li>• Double parking (both sides) is common during the night due to stoppages by trucks on transit effectively narrowing the road</li> </ul>	<ul style="list-style-type: none"> <li>• Provide appropriate road signs</li> <li>• Provide designated pedestrian crossing (raised pedestrian crossings/table tops are more desirable as they double up as speed calming measures)</li> <li>• Provide speed limits along the area</li> <li>• Provide traffic calming measures</li> <li>• Enhance sensitization to all road users and enforcement of safety</li> <li>• Redesign the side road junction to Koranorya market to provide for adequate turning radius and speed change (acceleration and deceleration) lanes</li> <li>• Provide designated parking areas (elongated lay bays) on either side of the road as well as designated bus bays</li> <li>• In the long term, consider provision of service lanes with controlled access to the main road</li> </ul>

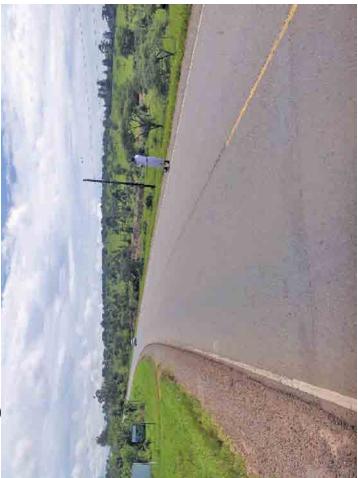
<ul style="list-style-type: none"> <li>Sharp horizontal curve into a crest curve</li> <li>No center line markings only edge markings are visible hence drivers tend to overtake causing accidents</li> <li>Speeding motorists and dangerous overtaking are common at the location</li> </ul>	<ul style="list-style-type: none"> <li>Run off and head on collisions are possible at the location</li> </ul>	<ul style="list-style-type: none"> <li>Provide retro-reflective continuous center line marking in addition to delineator road studs</li> <li>Re-application of thermoplastic paint on the edge lines</li> <li>Enhanced road signage warning motorists accordingly</li> </ul>

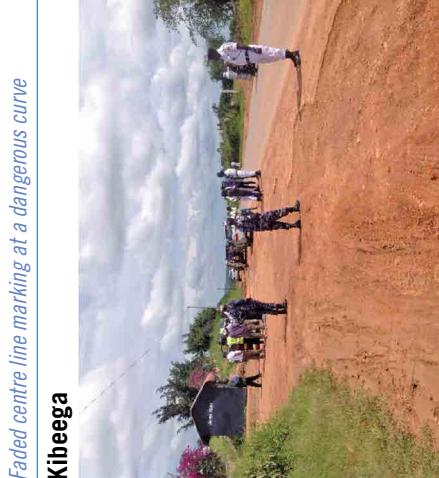
<p><i>Faded centre line marking at a dangerous curve</i></p>	<ul style="list-style-type: none"> <li>Missing advance warning signage to indicate the presence of a junction</li> <li>Missing Stop/Give Way signage on the minor road</li> <li>Drivers entering and exiting to the minor road arbitrarily responsible for a number of crashes</li> <li>Blind corners at a crest</li> <li>Side Road to Kiruhura at the crest of the vertical curve</li> <li>Road marking along the location completely faded</li> <li>Rugged road shoulders</li> <li>No road signs both on the highway and minor side road</li> </ul>	<ul style="list-style-type: none"> <li>Motorists exiting to or joining from the gravel access headless of other traffic causes the location to be a hazardous spot</li> <li>Installation of Junction Ahead signs on either side of the location</li> <li>Installation of Stop/Give Way signage on the minor road</li> <li>Redesign the side road junction to provide adequate turning radius and speed change (acceleration and deceleration) lanes</li> <li>Rehabilitation of the deteriorated road edges</li> <li>Need of maintenance of the road side and clearing of the roadside bushes to increase visibility splays</li> <li>In the long term, consider improvement of the vertical curve to improve on the sight distances</li> </ul>

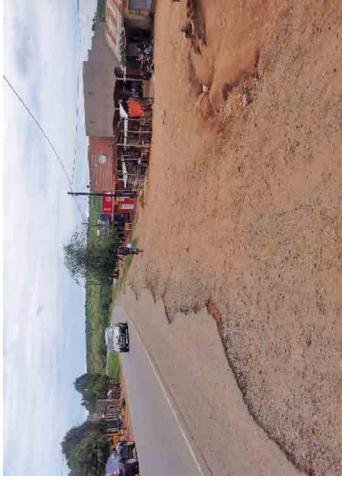
<p>The location has been declared very dangerous by traffic Police</p> <p>Built-up area (trading center) on a rolling terrain with a blind corner</p> <p>No pedestrian crossing facilities</p> <p>Road markings are faded</p> <p>No road signs</p> <p>Vehicles park on the road on either side due to lack of designated parking areas</p> <p>Accidents mainly are due to over speeding and reckless driving</p>	<ul style="list-style-type: none"> <li>Over speeding vehicles cause frequent crashes involving pedestrians and motorcycles.</li> <li>According to traffic Police, this location is #2 in terms of prioritization</li> </ul>	<ul style="list-style-type: none"> <li>Application of retroreflective road marking (including a continuous yellow centre line at the location) and delineator road studs</li> <li>Provide appropriate road signs (speed limit and advance warning signs)</li> <li>Provide pedestrian crossing facilities for safe cross road movements by pedestrians</li> <li>Provide speed calming facilities on the approaches to the centre</li> <li>Rehabilitation of the deteriorating road edges and improvement of the RHS access to provide for speed change lanes</li> <li>Enhance sensitization to all road users and enforcement of safety</li> <li>Consider provision of streetlights to illuminate the centre at night.</li> </ul>

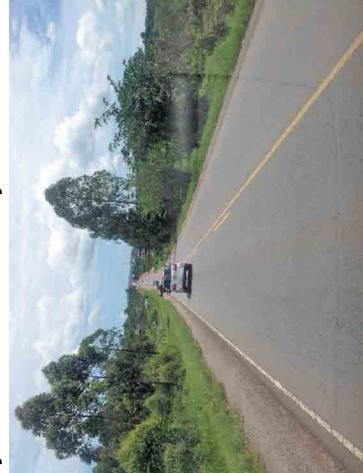
<p><i>Relatively straight and gently sloping stretch prompts motorists to overspeed and overtake dangerously</i></p> <ul style="list-style-type: none"> <li>It is a straight and gently sloping section of the road which encourages motor vehicles overspeeding</li> <li>It has insufficient signage for speed limit and warning of incoming traffic from community road. Hence Vehicles hit humps and overturn</li> <li>The road markings are visible but not reflective at night</li> <li>Side road junction leading to two (2) schools with insufficient turning radius</li> </ul>	<ul style="list-style-type: none"> <li>Most of the accidents are head-on and roll-over occurring at night due to over speeding coupled with invisible markings</li> </ul>	<ul style="list-style-type: none"> <li>Provide appropriate Road signs and relocate the existing speed limit signs to match the area development</li> <li>Need of a speed limit (e.g. 50 Km) signage at the crest</li> </ul>	<ul style="list-style-type: none"> <li>Repaint the road markings with approved reflective paint and install delineator studs to the center and edge line markings</li> <li>Enhance sensitization to all road users and enforcement of safety</li> <li>Redesign the LHS side road junction to provide adequate turning radius and speed change (acceleration and deceleration) lanes</li> <li>Consider installation of streetlights to illuminate the stretch at night</li> </ul>

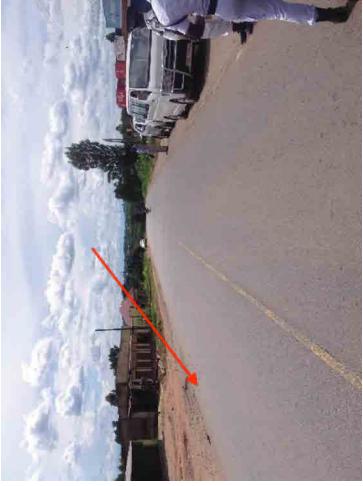
<p><i>Centre lacks designated pedestrian crossings and road markings are faded</i></p>	<ul style="list-style-type: none"> <li>Built-up area (trading center) on a rolling terrain</li> <li>The location is a notorious hazardous spot known for near daily accidents which involve children</li> <li>No provision for pedestrian crossings</li> <li>No road signs</li> <li>Road markings are faded</li> <li>Eroded shoulders at a side road junction cause the vehicles joining the highway to delay at the junction</li> </ul> <ul style="list-style-type: none"> <li>Reckless driving and over speeding responsible for most pedestrian knockdowns</li> </ul> <ul style="list-style-type: none"> <li>Provide appropriate Road signs</li> <li>Repaint the road markings with approved reflective paint and install delineator studs to the center and edge line markings</li> <li>Provide designated pedestrian crossing facilities for safe crossing movements</li> <li>Enhance sensitization to all road users and enforcement of safety</li> <li>Repair of the eroded shoulders</li> <li>Redesign the RHS side junction to provide adequate turning radius and speed change (acceleration and deceleration) lanes</li> </ul>

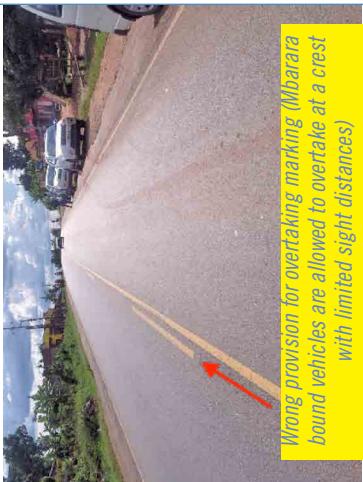
<p><i>Wrong provision for overtaking marking (Mbarara bound vehicles are allowed to overtake at a crest with limited sight distances)</i></p>	<p>Overtaking priority at the crest</p>

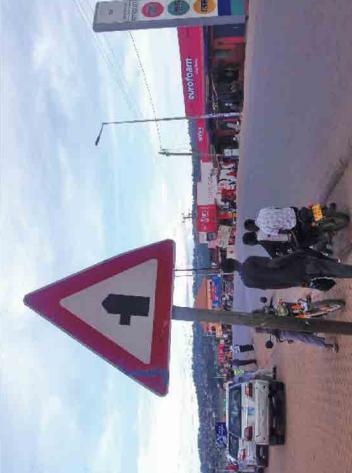
<ul style="list-style-type: none"> <li>The centre is on a descent and pedestrian knock downs are likely due to the multiple crossing movements</li> </ul>	<ul style="list-style-type: none"> <li>Application of retroreflective road marking and installation of delineator road studs</li> <li>Repaint the speed humps and crossing points with retro-reflective paint</li> <li>Provide appropriate road signs (speed humps ahead warning signs)</li> <li>Provide speed restrictions (speed limit signs)</li> <li>Enhance sensitization to all road users and enforcement of safety</li> <li>Provide designated bus stop bays on either side the road</li> <li>In the long term, consider provision of service lanes to the town</li> </ul>

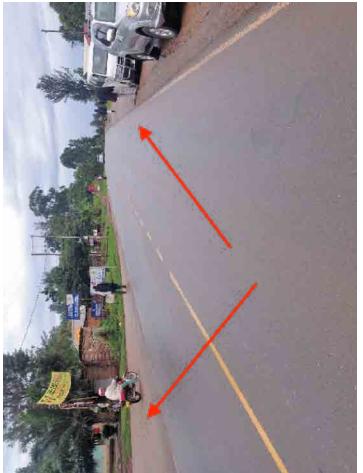
<ul style="list-style-type: none"> <li>Vehicles using the accesses tend to cut across main carriageway traffic at a bend creating a safety hazard</li> <li>Side impact collisions are therefore common at the location</li> <li>Pedestrian knockdowns are also common</li> </ul>	<ul style="list-style-type: none"> <li>Installation of appropriate advance warning signs (pedestrian crossings and junction ahead signage)</li> <li>Provision of pedestrian crossings at a safe distance from the blind spot (raised pedestrian crossings/table tops are more desirable at the location)</li> <li>Provide speed restrictions (speed limit signs)</li> <li>Repair of the deteriorating shoulders</li> <li>Sensitization of road users and enforcement of safety</li> <li>Redesign the junction to create a staggered intersection</li> </ul>

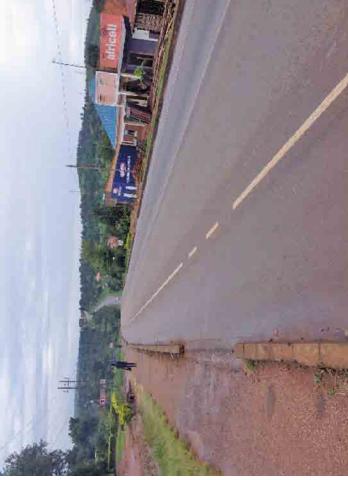
<p><i>Steep ascent towards Matanga tends to prove difficult for ascending HGVs</i></p>		
17.	<b>Kamutuzza</b>		<ul style="list-style-type: none"> <li>Descending vehicles have the freedom to overtake as a result of poor road markings</li> <li>Limited sight distances at the vertical crest from either side</li> <li>Speeding motorists, dangerous overtaking</li> </ul>	<ul style="list-style-type: none"> <li>Accidents occur at climbing lane termination point due to overspeeding and absence of proper markings and signage</li> <li>Provide appropriate road signs (consider informative signs cautioning against overtaking and urging motorists to observe lane discipline)</li> <li>Enhance sensitization to all road users and enforcement of safety</li> <li>Reconfigure the road markings to prohibit descending vehicles from overtaking</li> </ul>

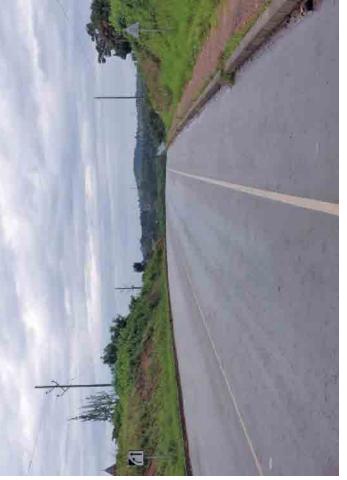
<p><i>Both climbing lanes at a vertical crest with limited sight distances</i></p>

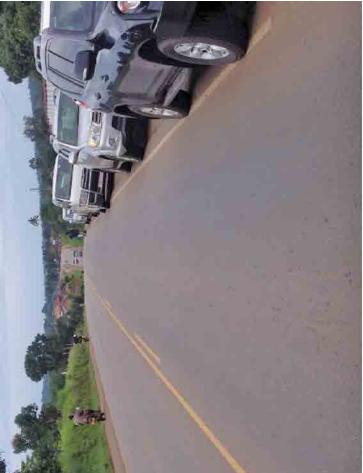
<ul style="list-style-type: none"> <li>Rolling terrain high speed section</li> <li>Road marks are clear</li> <li>Overtaking road markings extend to the middle of the ascent limiting the driver's sight distance</li> </ul> <p><i>Road marking allows Kampala bound traffic to overtake on sections with limited sight distances</i></p>	<ul style="list-style-type: none"> <li>Accidents are due to over speeding and reckless driving</li> <li>Overtaking line misused by drivers</li> </ul>	<ul style="list-style-type: none"> <li>Enhance sensitization to all road users and enforcement of safety (overspeeding and reckless overtaking the main concerns at the location)</li> <li>Prohibit overtaking by providing a solid center line reflective marking with studs</li> <li>Reconfigure the road markings with a focus on safety notwithstanding sight distance at the stretch</li> </ul>

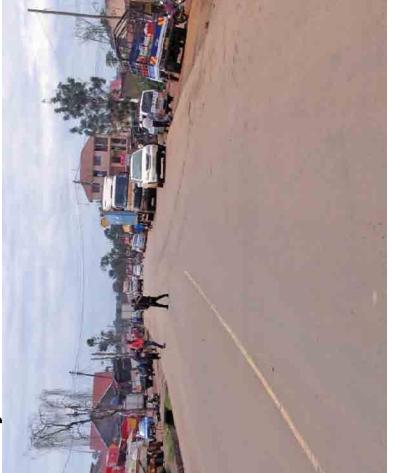
<ul style="list-style-type: none"> <li>Important trading centre</li> <li>Very Busy town where truck drivers park to rest mostly at night (serves as a road side station)</li> <li>Weighbridge located along the stretch</li> <li>Trucks park on either side of the highway narrowing the carriage way due to lack of designated parking</li> <li>Faded edge line markings</li> </ul>	<ul style="list-style-type: none"> <li>Accidents occur due constriction of carriageway by stopping trucks and heightened pedestrian activities.</li> </ul>	<ul style="list-style-type: none"> <li>Provide designated pedestrian crossing (raised pedestrian crossings/table tops are more desirable to calm speeds)</li> <li>Provide appropriate road signs</li> <li>Reinstate the humps and rumble strips</li> <li>Application of retroreflective road marking and installation of delineator road studs</li> <li>Enhance sensitization to all road users and enforcement of safety (vendors to be also restricted from main carriageway)</li> </ul>

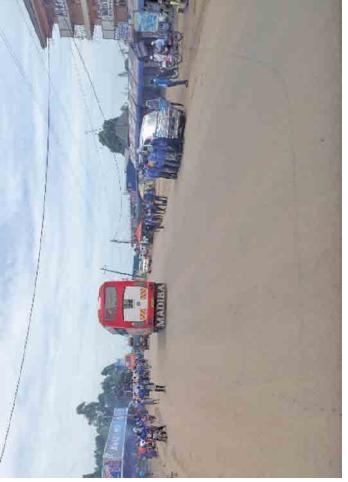
<i>Missing designated bus bays and parking facilities</i>

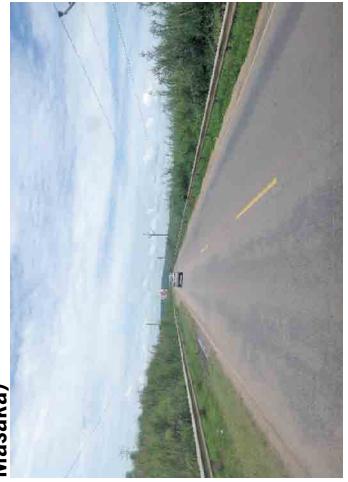
S/N	Name of the Spot	Survey Observations and Findings	Analysis/Diagnosis	Suggested Recommendation for improvement
Chain-age (Km)				
21.	<b>Buyaya</b>	<ul style="list-style-type: none"> <li>New Shell fuel station on the RHS close to the road along the curve</li> <li>Vehicles from the main road enter the fuel station use the designated exit and vice versa, which leads to accidents</li> <li>No road signs</li> <li>Overtaking common despite presence of a continuous yellow centre line</li> <li>No protection along the swamp</li> </ul>

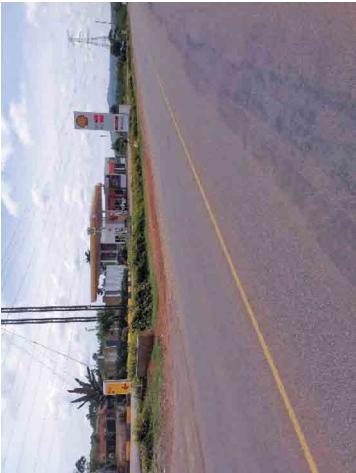
<ul style="list-style-type: none"> <li>Motorists sometimes fail to observe entry and exit points to the newly developed service/petrol station causing accidents</li> </ul>	<ul style="list-style-type: none"> <li>Provide road signs informing motorists on the station ahead</li> <li>Provision of speed calm measures in the form of rumble strips on the approaches to the station</li> <li>Enhance sensitization to all road users and enforcement of safety</li> <li>Consider provision of acceleration and deceleration lanes at the entry and exit preferably to be implemented by the fuel station</li> <li>In addition, redesign the section to include storage and weaving lanes to allow for turning movements into and out of the station</li> </ul>

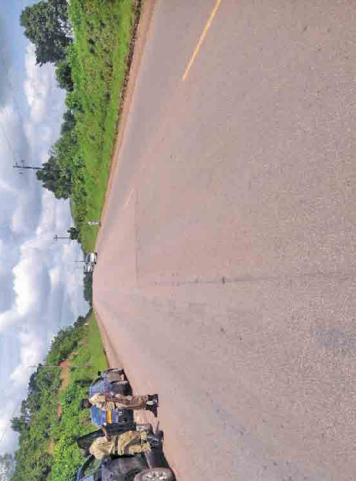
<ul style="list-style-type: none"> <li>The climbing lane marking needs</li> </ul>	<ul style="list-style-type: none"> <li>Provide appropriate road signs (beginning and end of climbing lanes)</li> <li>Application of retroreflective marking to clearly demarcate the climbing lane and installation of delineator road studs to mark the lane extents</li> <li>Enhance sensitization to all road users and enforcement of safety</li> <li>Reconfigure the road markings to prohibit descending vehicles from overtaking</li> </ul>

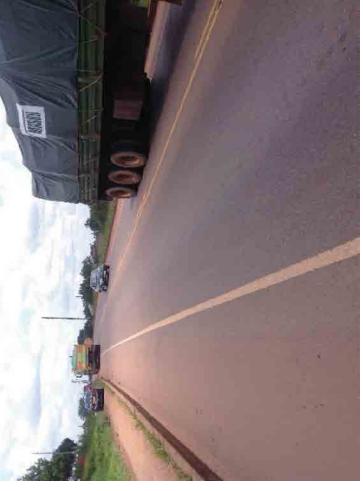
<ul style="list-style-type: none"> <li>Predominant accidents are mainly hit and run involving pedestrians as well as head on collisions</li> </ul>	<ul style="list-style-type: none"> <li>Provide appropriate road signs</li> <li>Enhance sensitization to all road users and enforcement of safety</li> <li>Reconfigure the road markings to prohibit descending Masaka bound vehicles from overtaking</li> </ul>

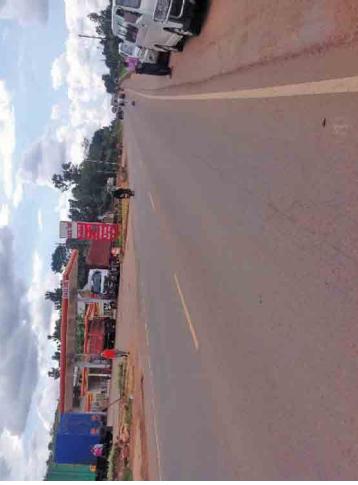
<ul style="list-style-type: none"> <li>Straight stretch terminating into curves on a rolling-flat terrain</li> <li>Built-up high speeding area with a fuel station close to the road</li> </ul>	<ul style="list-style-type: none"> <li>Most accidents are head-on and rear end for vehicles joining the highway from and to the fuel station because of lack maneuverability lane by fueling trucks</li> </ul>	<ul style="list-style-type: none"> <li>Provision of a 50kph speed limit sign and informative sign on the fuel station ahead</li> <li>Enhance sensitization to all road users and enforcement of safety especially in regard to overspeeding and overtaking dangerously</li> <li>Reconfigure the road markings to prohibit overtaking</li> <li>Consider provision of acceleration and deceleration lanes at the entry and exit preferably to be implemented by the fuel station</li> <li>In addition, redesign the section to include storage and weaving lanes to allow for turning movements into and out of the station</li> </ul>

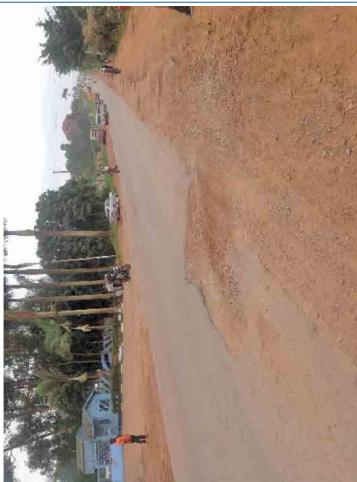
*Pothole on the LHS lane. Note the deteriorated edges and faded road marking*

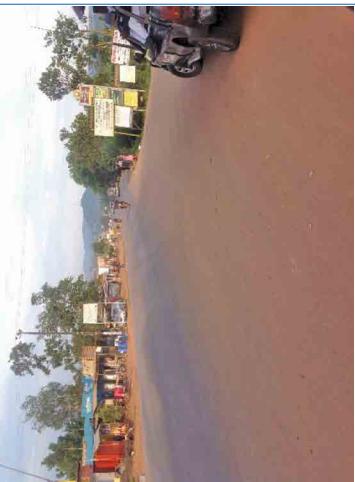
<p><i>Faded road marking at the RHS junction</i></p>

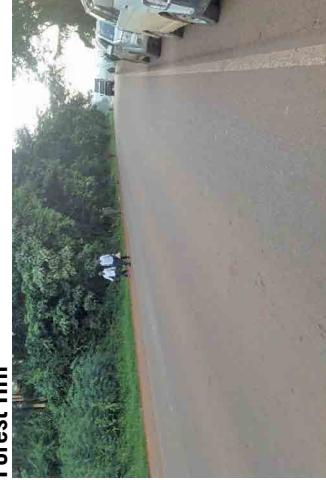
<p><i>Overgrown twigs on the RHS jutting into the carriageway obstructing sight distances</i></p>	<ul style="list-style-type: none"> <li>• Rolling terrain section with a short sag curve and a crest</li> <li>• High speeding zone that prompts drivers to recklessly overtake</li> <li>• No road markings</li> <li>• Overgrown vegetation</li> <li>• Accidents are mostly fatal due to over speeding and overtaking</li> </ul>	<ul style="list-style-type: none"> <li>• Provide appropriate road signs</li> <li>• Re-establish the road markings</li> <li>• Provide a solid centerline marking to prohibit overtaking</li> <li>• Provide speed restrictions</li> <li>• Clearing of overgrown vegetation to improve sight distances</li> <li>• Enhance sensitization to all road users and enforcement of safety</li> </ul>

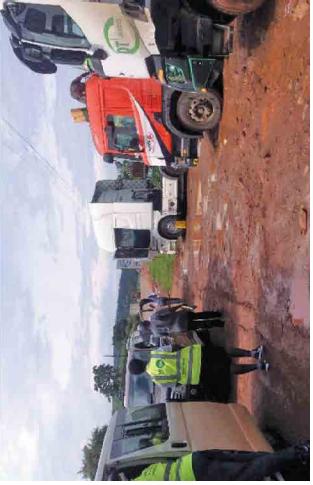
<p><i>Heavy trucks washing area on the LHS</i></p>		<ul style="list-style-type: none"> <li>Provide appropriate road signs</li> <li>Enhance sensitization to all road users and enforcement of safety</li> <li>Provide road markings to prohibit descending vehicles from overtaking</li> <li>Carry out bush clearing and ensure routine maintenance</li> <li>Engage owners of cane plantations not to use the road reserve</li> <li>Designation of a proper heavy vehicles washing facility at a safe distance from the live carriageway</li> </ul>

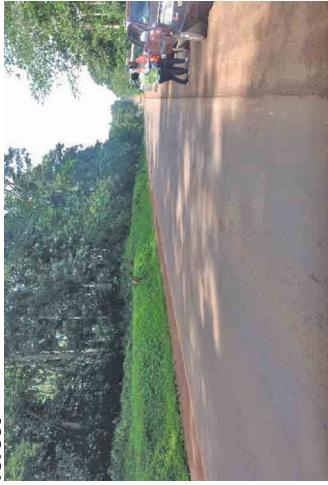
<ul style="list-style-type: none"> <li>Traffic police has mentioned this stretch as one of the most dangerous section in the county</li> </ul>	<ul style="list-style-type: none"> <li>Provide enhanced retro-reflective road signs warning motorists accordingly</li> <li>Enhance sensitization to all road users and enforcement of safety</li> <li>Application of road marking to mark lane extents with special emphasis on continuous yellow centreline to prohibit overtaking at dangerous spots</li> <li>Installation of delineator road studs along the forest</li> <li>Provide street lights</li> </ul>

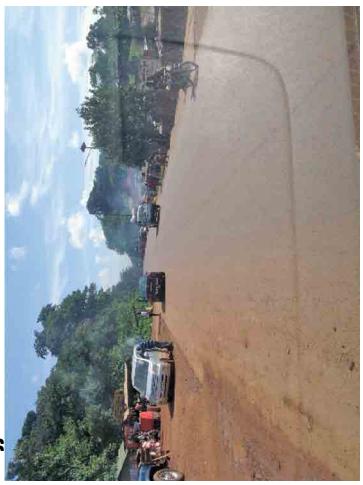
<p><i>Missing bus bays at Najjembe centre</i></p>	<ul style="list-style-type: none"> <li>Provide appropriate road signs (speed limits on to the centre, pedestrian crossing signs etc)</li> <li>Need to widen the road</li> <li>Provide a designated pedestrian crossing at the centre</li> <li>Application of road marking to mark lane extents</li> <li>Provide a solid centerline marking to prohibit overtaking</li> <li>Limit access to the carriageway and provide service lanes</li> </ul>	<ul style="list-style-type: none"> <li>Redesign the section to provide for temporary lay bays and designated bus bays for PSVs</li> </ul>

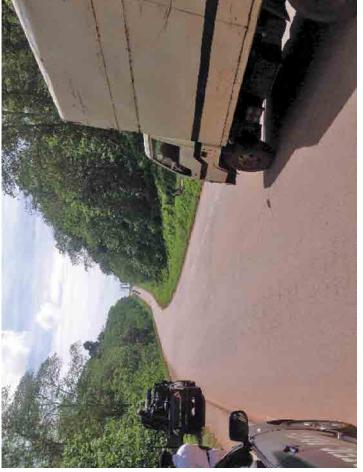
<ul style="list-style-type: none"> <li>Vertical alignment prompts vehicle to overspeed leading to dangerous overtaking that often end in head-on accidents</li> <li>Sharp horizontal alignment creates insufficient safe stopping sight distance that causes head-on accidents in the event of overtaking</li> </ul>	<ul style="list-style-type: none"> <li>Installation of no overtaking and speed limit signage</li> <li>Application of road marking to mark lane extents and clearly define the climbing lanes using retro-reflective paint</li> <li>Installation of beginning and end of climbing lane signage)</li> <li>Road marking prohibiting overtaking</li> <li>Clearing of the marauding roadside vegetation</li> </ul>

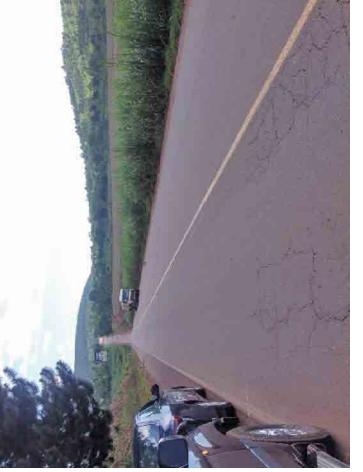
<ul style="list-style-type: none"> <li>Dangerous overtaking at blind spot often leads to head-on accidents</li> </ul>	<ul style="list-style-type: none"> <li>Clearing of the sugarcane within the road reserve</li> <li>Installation of speed limit and no overtaking warning signage</li> <li>Revision of road marking to limit overtaking</li> <li>Construction of climbing lane to widen traffic winding area at the curve</li> </ul>

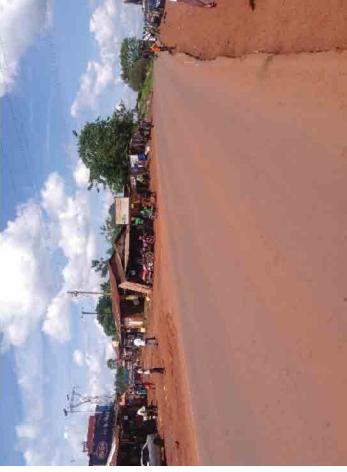
<p><i>Missing pedestrian crossings. Note the eroded shoulders and lack of bodaboda parking facilities</i></p>		<ul style="list-style-type: none"> <li>Road marking is faded; allows for overtaking from both sides but drivers lack adequate sight distances because of the crest</li> <li>Poor road marking</li> <li>Missing signage</li> </ul>
					<ul style="list-style-type: none"> <li>Dangerous overtaking leads to frequent pedestrian crashes</li> </ul>
					<ul style="list-style-type: none"> <li>Speed limit signage</li> <li>Application of retro-reflective road marking and delineator road studs</li> <li>Expansion of road to provide for overtaking and climbing lanes</li> </ul>

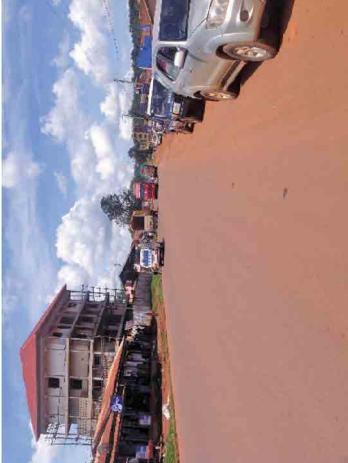
<ul style="list-style-type: none"> <li>Overspeeding in a crowded trading center often leads to crashes.</li> </ul>	<ul style="list-style-type: none"> <li>Speed limit signage</li> <li>Application of retro-reflective road marking and delineator road studs</li> <li>Provision of speed calming measures on the approaches to the centre</li> <li>Provision of pedestrian crossing facilities</li> <li>In the long term, consider provision of service lanes with controlled access to the main road</li> </ul>

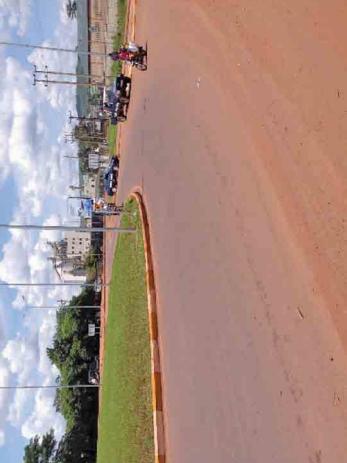
<ul style="list-style-type: none"> <li>Insufficient space often leads to veering off of heavy when they are unable to negotiate the curve</li> </ul>	<ul style="list-style-type: none"> <li>Review of the roundabout designs</li> <li>There is a need for reduction of roundabout central island to create more traffic circulatory roadway</li> <li>Provide for speed limit signs</li> <li>Application of appropriate road marking at the roundabout to channelize traffic properly</li> </ul> <p><i>Sharp curve at the Nile Bridge roundabout</i></p>

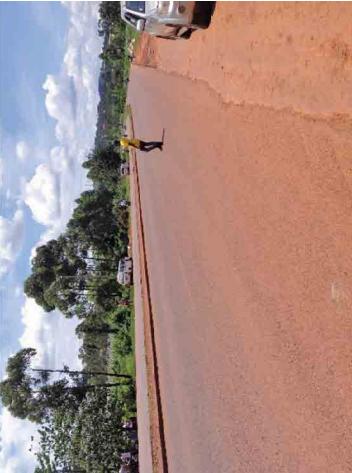
<p><i>Pedestrian crossing at a non-designated area. Road marking completely faded.</i></p>	<ul style="list-style-type: none"> <li>Straight section of the road with overspeeding traffic</li> <li>There is no designated pedestrian crossing point</li> <li>Lack of road markings</li> <li>Pedestrians are knocked when crossing to join the stage</li> <li>No gazetted stage or bus stop</li> <li>Unsafe road user behavior especially by motorcyclists</li> </ul>	<ul style="list-style-type: none"> <li>Absence of pedestrian crossing facilities leads to pedestrians crashes by overspeeding motorists</li> <li>Need for designated bus bays</li> <li>Application of retro-reflective road marking</li> <li>Sensitization and enforcement to ensure safe road user behavior by all</li> </ul>

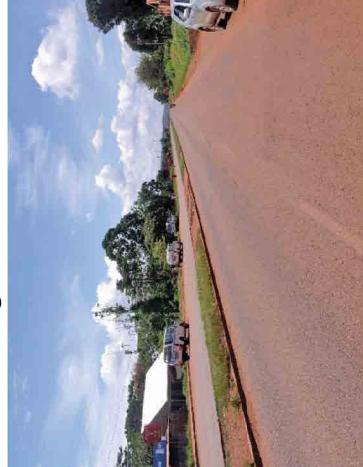
<ul style="list-style-type: none"> <li>Careless driving and overtaking</li> <li>Most of accidents are head-on collision</li> <li>Rolling terrain into a deep valley on a straight section</li> <li>Distressed carriageway pavement and failing road shoulders eats into the traffic lanes</li> </ul>	<ul style="list-style-type: none"> <li>Overspeeding vehicles on a rolling terrain get involved heads-on collision leading to fatal and serious accidents</li> <li>Dangerous overtaking at this section leads to accidents too</li> <li>Traffic police mentioned over ten (10) accidents at this spot this year</li> </ul> <ul style="list-style-type: none"> <li>A climbing lane be provided to accommodate heavy goods vehicles and the slower vehicles.</li> <li>Appropriate signs should be put in place to caution motorists i.e. speed limit.</li> <li>Rehabilitation of the whole section</li> <li>Application of retro-reflective road marking along the stretch</li> <li>Enforcement of speed limits (speed monitoring cameras would be appropriate in light of the high number of accidents reported)</li> </ul>

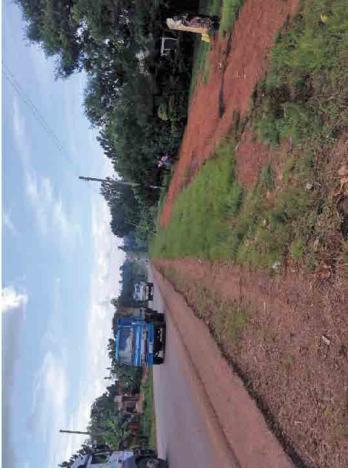
<ul style="list-style-type: none"> <li>Overspeeding vehicles do dangerous overtaking leading to heads-on accidents or self-involving accidents that leads to fall into deep roadside ditches.</li> </ul>	<ul style="list-style-type: none"> <li>Provision of guardrails on the high embankment at the trough of the vertical curve</li> <li>Road marking and installation of road signs</li> <li>Rehabilitation of failing pavement</li> <li>Installation of hazard marker and height restriction signs at the bridge near the location</li> </ul>

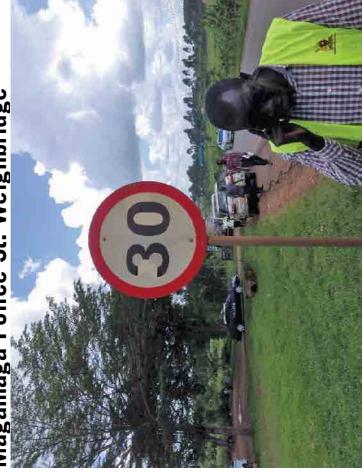
<p><i>Speed limit sign erroneously reflects as 80kph during the night</i></p>	<ul style="list-style-type: none"> <li>Dangerous overtaking by overspeeding vehicles leads to heads-on accidents</li> <li>Improvement of signage and road marking</li> <li>Replacement of the speed limit sign board with a new 30kph speed limit sign</li> <li>Rehabilitation of the stretch</li> <li>Installation of safety guardrail on the high embankment sections</li> </ul>

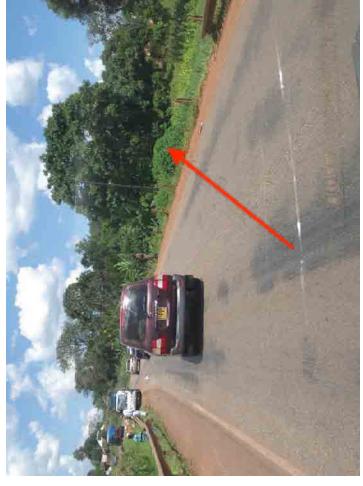
<p><i>Missing safety fences. Accident involving a medium goods vehicle carrying agricultural produce on the LHS</i></p>

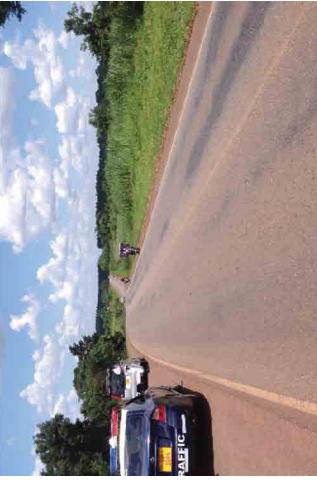
<p><i>Completely faded centre line marking</i></p>	<ul style="list-style-type: none"> <li>A tight junction joining a main Malaba-Kampala highway</li> <li>Traffic Police mentioned accidents every week at this spot caused by motorists entering Iganga</li> <li>Access on the LHS lacks speed change lanes</li> <li>Missing speed calming measures on the approaches to the junction</li> </ul>	<ul style="list-style-type: none"> <li>Joining traffic often collide with speeding motorists on the highway leading to fatal and serious accidents</li> <li>Improvement of the junction and introduction of speed change lanes</li> <li>Widening of the carriageway to accommodate storage lanes</li> <li>Provision of speed calming measures</li> </ul>

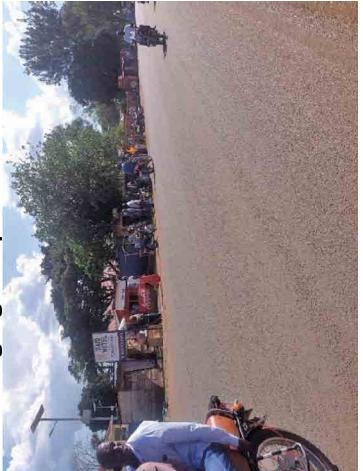
<ul style="list-style-type: none"> <li>Overspeeding motorists involve pedestrian crashes, involving fatal and serious accidents</li> </ul>	<ul style="list-style-type: none"> <li>Provision of pedestrian crossing facilities</li> <li>Provision of a footbridge as a long term solution</li> <li>Speed control factors in the form of speed calming measures (speed humps, rumble strips)</li> <li>Provide retroreflective road marking at the location and delineator road studs</li> <li>Installation of speed limit signs</li> </ul>

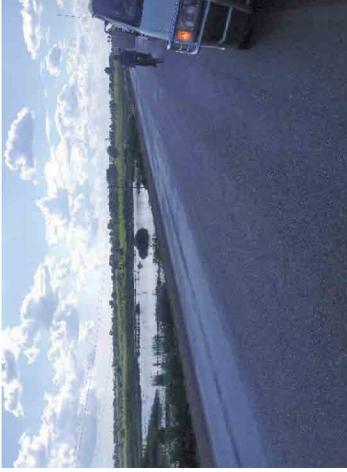
<ul style="list-style-type: none"> <li>• Deep clear zone at the bridge approach normally leads to tip over.</li> <li>• The area is marred by visibility problems in the morning hours due to fog</li> </ul>	<ul style="list-style-type: none"> <li>• Rehabilitation of the pavement</li> <li>• Provision of proper signage</li> <li>• Provision of retro-reflective road marking(consider restricting overtaking)</li> <li>• Provide guardrails on both sides of the road to avoid cars/trucks going off in the swamp</li> </ul>

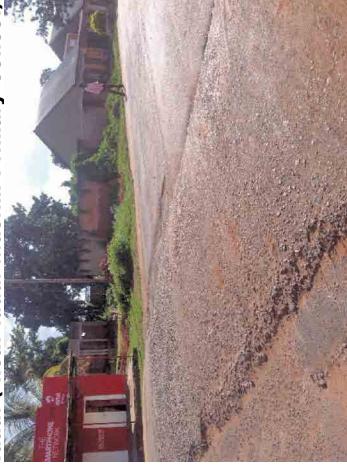
<ul style="list-style-type: none"> <li>Too wide and too high speed hump leading to rear end collisions due to difficulties in climbing over it by vehicles</li> <li>No warning signage before reaching the traffic hump</li> <li>Faded road marking</li> </ul>	<ul style="list-style-type: none"> <li>This out of proportion speed hump causes vehicles to make abrupt stops leading to rear end and run off accidents</li> </ul>	<ul style="list-style-type: none"> <li>Redesign and standardize the hump to allow for safe passage of traffic</li> <li>Provision of sufficient speed rumble strips on the approaches to the hump</li> <li>Appropriate warning signage i.e speed hump ahead signs</li> <li>Application of retro-reflective road marking both on the carriageway and on the speed hump</li> </ul>

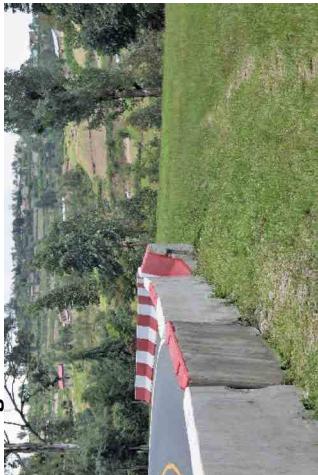
*Dislodged crash barrier*
