NORTHERN CORRIDOR TRANSIT AND  
TRANSPORT COORDINATION AUTHORITY

# REPORT ON BLACK SPOTS SURVEY ALONG THE NORTHERN CORRIDOR ROUTES IN RWANDA AND UGANDA

20 March 2020

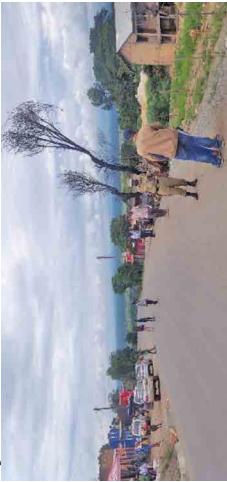
S/N	Name of the Spot	Chain-age (Km)	Survey Observations and Findings	Analysis/Diagnosis	Suggested Recommendation for improvement
11.	Parkview				
12.	<b>Kyambura Market Centre</b>		<ul style="list-style-type: none"> <li>Sharp combined curves on rolling-mountainous terrain</li> <li>Built-up area with a daily market</li> <li>The road is under rehabilitation and this particular section has been sealed but a climbing lane and lane separation have not been considered</li> <li>This is the exact location where over 22 people perished in August 2019 when a fuel tanker got an accident</li> </ul> <p><i>Wreckage of a fuel tanker that was involved in a catastrophic run off accident</i></p>

<p><i>Extremely sharp curve at the market centre with no provision for safety fences on high embankment</i></p>	<ul style="list-style-type: none"> <li>The stretch traverses a hilly to mountainous terrain with successive combinations of horizontal and vertical curves</li> <li>Provide appropriate road signs along the stretch(speed limit and sharp curve ahead warning signs)</li> <li>Provide pedestrian crossing facilities for safe cross road movements within the market</li> <li>Installation of safety fences (flex beam guardrails with reflective studs) and directional arrow (chevron) signs at the tight curves</li> <li>Enhance sensitization to all road users and enforcement of safety</li> <li>Review the design to consider: <ul style="list-style-type: none"> <li>- Lane separation with central medians</li> <li>- Speed calming humps and rumble strips to the descending lane</li> <li>- Provision of climbing lanes</li> <li>- Redesign the RHS side junction to provide adequate turning radius and speed change (acceleration and deceleration) lanes</li> </ul> </li> </ul>

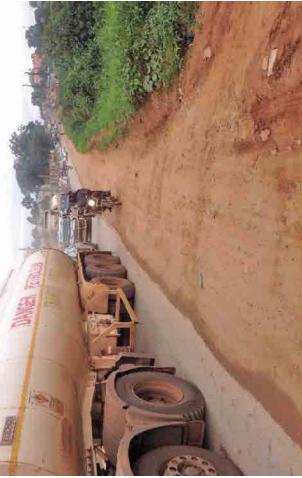
3.	<b>Seeta High School</b>

<ul style="list-style-type: none"> <li>Road shoulders and part of the carriageway are eroded resulting to a narrow carriageway</li> <li>Need for a climbing lane</li> <li>Road under rehabilitation</li> <li>Faded road marking</li> </ul>	<ul style="list-style-type: none"> <li>Widening and rehabilitation of the carriageway (Dualling at the section would be more preferable owing to the traffic volumes)</li> <li>Application of retro-reflective road marking and installation of delineator road studs</li> <li>Redesign the road markings to prohibit overtaking</li> <li>Provision of NMT facilities along the stretch including cycle tracks and pedestrian walkways</li> <li>Provide appropriate road signs</li> <li>Provide speed restrictions</li> <li>Provision of streetlights to illuminate the stretch</li> </ul>

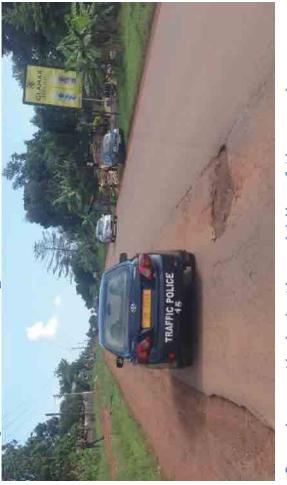
15.	<b>Sagazi</b>		<p><i>Gapping pothole in the middle of the carriageway</i></p>

<ul style="list-style-type: none"> <li>Horizontal curve at the trough of the vertical curve makes the location susceptible to dangerous driving</li> <li>A rolling section terminating in a blind curve and sag curve</li> <li>Presence of a market</li> <li>Climbing lanes from the vertical trough</li> <li>Overspeeding and failure to observe lane discipline a safety concern</li> <li>Faded road markings</li> <li>No road signs</li> <li>Bus stop located close to a sag curve (poorly located)</li> </ul> <ul style="list-style-type: none"> <li>Provide appropriate road signs</li> <li>Enhance sensitization to all road users and enforcement of safety</li> <li>Application of road marking to mark lane extents and clearly define the climbing lanes</li> <li>Provide road markings to prohibit descending vehicles from overtaking</li> <li>Redesign and relocate the bus stop to a safer location</li> </ul>

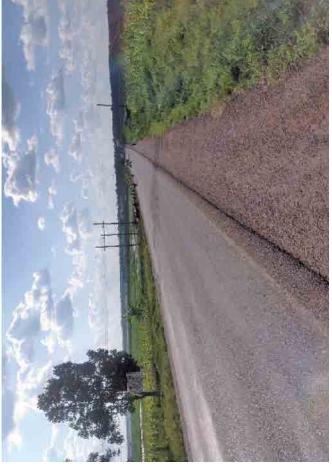
45.	<b>Igogero Valley (rice fields) in Bujiri District</b>

<ul style="list-style-type: none"> <li>Straight section with no signage to indicate speed limit and a bridge ahead.</li> <li>Missing/faded road markings.</li> <li>Motorists killed due to careless overtaking and over speeding</li> <li>Truck drivers using free gear</li> <li>Damaged safety fences</li> </ul>	<ul style="list-style-type: none"> <li>Dangerous overtaking leads to heads-on accidents</li> </ul>	<ul style="list-style-type: none"> <li>Appropriate signs should be put in place to warn/alert motorists i.e. speed limit and bridge ahead signage.</li> <li>Application of retro-reflective road marking to replace the already faded paint</li> </ul>

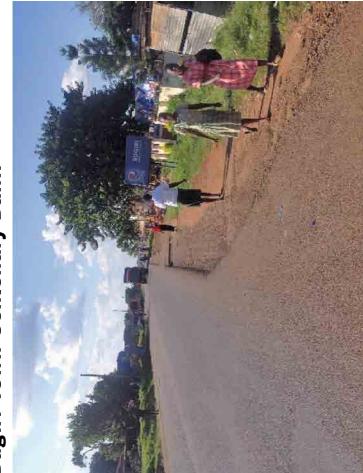
47.	<b>Bugiri Town-Centenary Bank</b>

<ul style="list-style-type: none"> <li>• Town located at the end of a descent from the Malaba side</li> <li>• Missing/faded road markings affecting judgment of traffic channeling.</li> <li>• No signage to indicate speed limit and humps ahead.</li> <li>• Dangerous humps ahead.</li> <li>• Careless overtaking /over speeding</li> <li>• Heavily loaded trucks trying to freewheel/overtake as they approach the town leading to serious accidents in case of loss of control</li> </ul> <ul style="list-style-type: none"> <li>• Speeding motorists through the center get involved in pedestrian crashes</li> <li>• Police traffic mentioned 5 fatal accidents have been reported in the past year involving trailers in head-on collision</li> </ul> <ul style="list-style-type: none"> <li>• Provision of appropriate signs (speed limit and speed humps ahead warning signs)</li> <li>• Provision of speed calming measures (rumble strips at regular intervals) on the sloping approach from the Malaba side.</li> <li>• Provision of pedestrian crossing facilities at the town (raised pedestrian crossings/table tops are more desirable at such a town as they double up as speed calming measures)</li> <li>• Application of retro-reflective road marking to replace the already faded paint</li> <li>• Installation of cameras for speed control especially from the Malaba side approach</li> </ul>

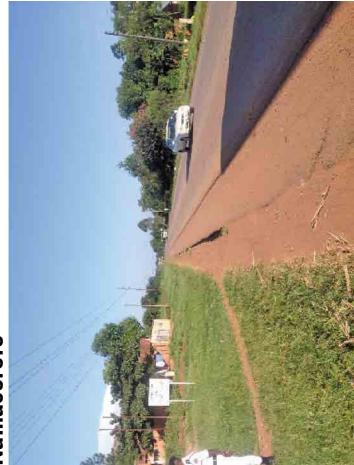
50.	<b>Namaserere</b>			<ul style="list-style-type: none"> <li>Straight section without proper road markings</li> <li>Over speeding</li> <li>Faded markings</li> <li>Distressed pavement</li> </ul>	<ul style="list-style-type: none"> <li>Provision of appropriate road markings and signage</li> <li>Roadside clearance to increase sight distances for motorists</li> </ul>

The very straight section prompts motorists to overspeed and overtake dangerously

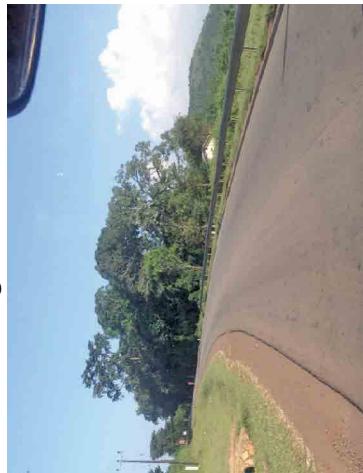
S/N	Name of the Spot	Chain-age (Km)	Survey Observations and Findings	Analysis/Diagnosis	Suggested Recommendation for improvement
54.	<b>Namutere Trading Centre</b>		<ul style="list-style-type: none"> <li>Overspeeding traffic through crowded trading center</li> <li>Sharp corners turning to the center</li> </ul>

<ul style="list-style-type: none"> <li>Overspeeding vehicles through the center normally get involved in accidents with pedestrians, <i>bodaboda</i> riders and PSVs at the center</li> </ul>	<ul style="list-style-type: none"> <li>Provision of speed calming measures</li> <li>Provision of advance warning signs (sharp curve ahead, speed limit, pedestrian crossing signs etc)</li> <li>Provision of designated <i>bodaboda</i> parking facilities</li> <li>Provision of appropriate road markings with emphasis on continuous yellow centerlines at the curves</li> <li>Sensitization of road users including motorists and pedestrians</li> </ul>

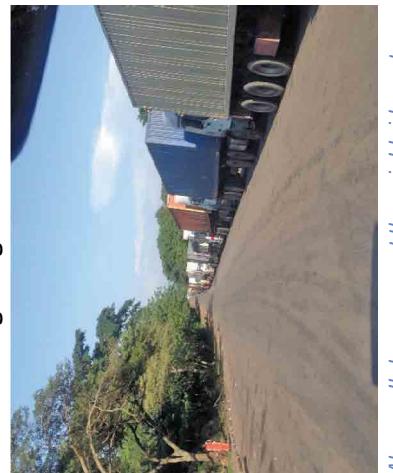
55.	<b>Busitema Weighbridge</b>		<ul style="list-style-type: none"> <li>Crowding weighbridge traffic spills onto the main carriageway</li> <li>Distressed pavement</li> <li>Overgrown tree branches and twigs jutting into the carriageway</li> </ul>

<ul style="list-style-type: none"> <li>Congestion at the weighbridge points causes traffic jam and accidents as through traffic try to overtake</li> </ul>	<ul style="list-style-type: none"> <li>Provision of ample traffic storage facilities at the weighbridge to address the long queues (consider separate entrance pavements)</li> <li>Application of retro-reflective road marking to replace the already faded paint</li> <li>Trimming of the overgrown twigs and branches to increase sight distances for motorists</li> </ul> <p><i>Abnormally long queue at the weighbridge entrance by heavy goods vehicles blocking through traffic</i></p>

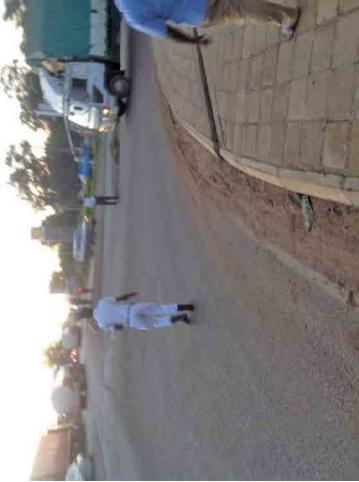
S/N	Name of the Spot <b>Corner (Tororo/Mbale Junction)</b>	Survey Observations and Findings

<ul style="list-style-type: none"> <li>• Overspeeding and dangerous driving</li> <li>• Traffic confusion due to lack of storage/weaving lanes</li> <li>• Faded road marking at the junction</li> <li>• Motorcyclist crowding</li> <li>• Bodaboda entering the highway without due regard for other traffic</li> <li>• No street lights</li> </ul>	Analysis/Diagnosis <ul style="list-style-type: none"> <li>• Provision of storage/weaving lanes along the main highway to allow for turning movements</li> <li>• Installation of necessary signage at the junction (Advance Directional signs on main road and Stop/Give Way signs at access roads)</li> <li>• Application of retro-reflective road marking and installation of delineator road studs at the junction</li> <li>• Provision of streetlights to illuminate the important junction</li> </ul>	Suggested Recommendation for improvement <ul style="list-style-type: none"> <li>• Provision of storage/weaving lanes along the main highway to allow for turning movements</li> <li>• Installation of necessary signage at the junction (Advance Directional signs on main road and Stop/Give Way signs at access roads)</li> <li>• Application of retro-reflective road marking and installation of delineator road studs at the junction</li> <li>• Provision of streetlights to illuminate the important junction</li> <li>• Installation of speed limit signs</li> <li>• Speed calming measures</li> <li>• Application of retro-reflective road marking to guide motorists</li> <li>• Sustained sensitization drives.</li> </ul>

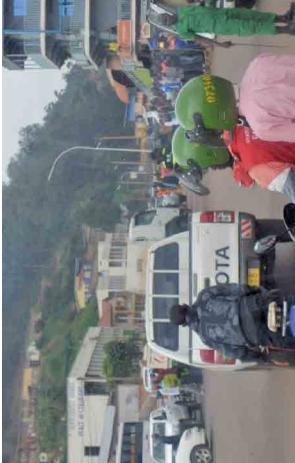
1.	Urban Exit road	2.39	<p>The area has a high contingent of motorcyclists and pedestrians walking along the road and making cross road movements.</p> <ul style="list-style-type: none"> <li>The carriageway is narrow inhibiting motorability of the road.</li> <li>Inadequate provision for Non-Motorized Traffic (NMT).</li> <li>No traffic separation facilities have been provided to segregate the directions of traffic.</li> </ul>

<p>Confluence of factors observed can lead to vehicle-motorcycle and vehicle-pedestrian crashes.</p>	<ul style="list-style-type: none"> <li>Expansion and channelization of the junction to cater for turning movements.</li> <li>Provision of adequate NMT facilities i.e pedestrian walkways, cyclist tracks, pedestrian footbridge if justified by pedestrian numbers etc.</li> <li>Separation of traffic directions to limit interaction between opposing traffic.</li> </ul>

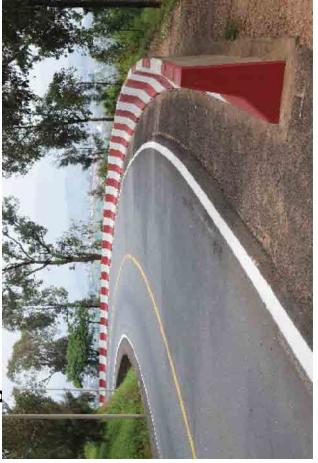
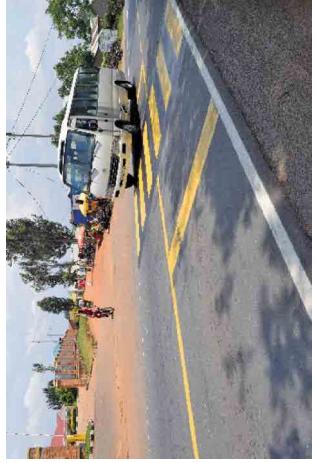
S/N	Name of the Spot	Chain-age (Km)	Survey Observations and Findings	Analysis/Diagnosis	Suggested Recommendation for improvement
2.	<b>Gihinga</b>	21.4-22.4	<p>The alignment is characterized by a combination of sharp horizontal and vertical curves winding through a hilly terrain. The following observations were also made:</p> <ul style="list-style-type: none"> <li>• Incorrectly positioned pedestrian crossing at the middle of an access junction near the 'Kamonyi District headquarters.</li> <li>• Missing pedestrian walkways along the relatively built up area.</li> <li>• The 'Sharp Left Curve Ahead' road sign just before the crash barriers has been partially obstructed by overgrown twigs.</li> <li>• Missing directional arrow signs at the crash barriers to warn motorists of sharp change of direction.</li> </ul>

<p><i>Incorrectly positioned pedestrian crossing (at an access junction)</i></p>	<ul style="list-style-type: none"> <li>• The narrowed carriageway in a sharply winding terrain might prompt motorists to veer off due to the increased centrifugal forces.</li> <li>• New Jersey crash barriers have however since been installed at some of the most hazardous locations.</li> <li>• Static speed cameras have also been installed to monitor speed limits along the stretch.</li> <li>• Missing directional arrow signs at the crash barriers to warn motorists of sharp change of direction.</li> <li>• Narrow carriageway with lane widths of 3m and 1.5m wide shoulders.</li> <li>• Missing safety fences along sharp curves on high and steep embankment.</li> </ul>	<ul style="list-style-type: none"> <li>• Installation of rumble strips at standard intervals at the beginning of the descent.</li> <li>• Provision of more concrete crash barriers along the alignment to prevent possible run off collisions.</li> <li>• Trimming vegetation around the road signs to increase visibility.</li> <li>• Installation of directional arrow signs and hazard marker signs at the beginning of the crash barriers.</li> <li>• Installation of delineator road studs to mark the lane extents on the carriageway.</li> <li>• Relocation of the pedestrian crossing to a safer location and provision of pedestrian walkways on either side.</li> <li>• In the long term, consider widening the carriageway (at least 3.5m lane width and 1.5m wide shoulders) with adequate NMT facilities and provision of climbing lanes where necessary.</li> </ul>

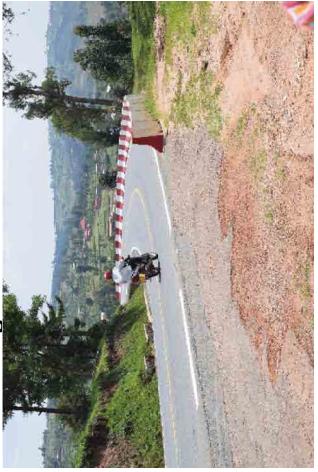
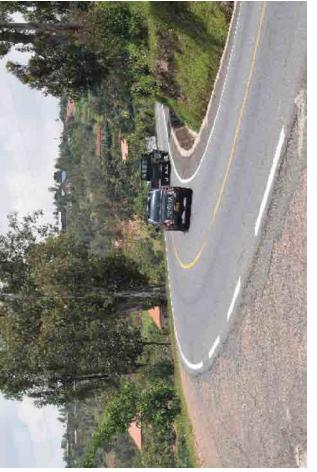
S/N	Name of the Spot	Chain-age (Km)	Survey Observations and Findings	Analysis/Diagnosis	Suggested Recommendation for improvement
3.	Gacurabwenge	24.4 - 25.4

<ul style="list-style-type: none"> <li>The stretch is on a rolling to mountainous terrain and is also characterized by sharp successive curves</li> <li>Premature termination of crash barriers on the RHS along the sharp curves on high and steep embankment</li> <li>Missing speed calming measures in the form of rumble strips.</li> <li>Missing delineator road studs to improve on visibility at night.</li> <li>Lack of directional arrow signs at the crash barriers and hazard marker signs at the beginning of the barriers.</li> </ul>	<ul style="list-style-type: none"> <li>The sharp curves along the section limit the sight distances for motorists increasing the likelihood of run off collisions.</li> </ul>	<ul style="list-style-type: none"> <li>Extension of the safety barriers to cover the curves on high and steep embankment.</li> <li>Installation of rumble strips at standard intervals at the beginning of the descent.</li> <li>Installation of retro-reflective delineator road studs to mark the lane extents at night.</li> <li>Installation of the missing directional arrow and hazard marker signs to warn motorists accordingly.</li> <li>Consider provision of street lighting to illuminate the stretch and hence improve on visibility at night.</li> <li>Realignment and widening of the road width in the long term.</li> </ul>

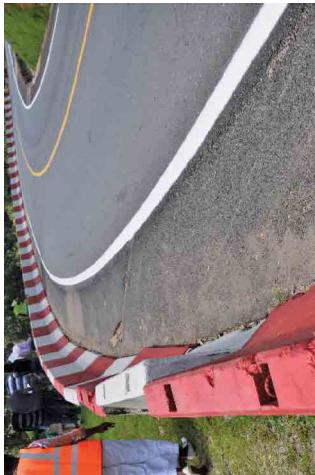
S/N	Name of the Spot	Chain-age (Km)	Survey Observations and Findings	Analysis/Diagnosis	Suggested Recommendation for improvement
4.	<b>Karengera curve</b>	36.2	<ul style="list-style-type: none"> <li>The section is a long, steep and winding descent necessitating crash barriers on the sharp curves.</li> <li>Some crash barriers have been knocked off and are dislodged from their natural positions.</li> <li>Missing directional arrow signs and hazard marker signs at the beginning of the crash barriers.</li> <li>Overgrown tree branches and twigs jutting into the motorable carriageway</li> </ul>	<ul style="list-style-type: none"> <li>The sharp curves make the descent prone to tangential skids and run-off collisions.</li> <li>An informative sign cautioning motorists and especially truck drivers to engage low gear is however in place at the beginning of the descent.</li> <li>Missing drainage chutes at the foot of the crash barriers to channel surface run off.</li> </ul>	<ul style="list-style-type: none"> <li>Installation of rumble strips at the beginning of the descent to act as a speed calming measure.</li> <li>Installation of retro-reflective delineator road studs to mark the lane extents at night.</li> <li>Installation of the missing directional arrow and hazard marker signs to warn motorists accordingly.</li> <li>Provision of street lighting to illuminate the stretch and hence improve on visibility at night.</li> <li>Trimming of the overgrown vegetation.</li> </ul>

*Concrete crash barriers on the LHS. Note the tangential skid off marks*

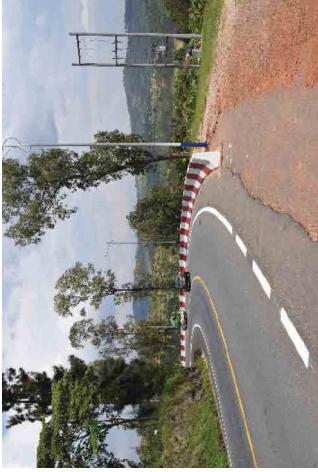
S/N	Name of the Spot	Chain-age (Km)	Survey Observations and Findings	Analysis/Diagnosis	Suggested Recommendation for improvement
6.	<b>Kivumu</b>

41	<ul style="list-style-type: none"> <li>Sharp curves on a rolling terrain characterize the section. Other observations include:           <ul style="list-style-type: none"> <li>Missing directional arrow signs at the curve and hazard marker signs at the beginning of the crash barriers.</li> <li>Missing delineator road studs to mark the carriageway.</li> <li>Lack of speed calming measures prompting motorists to speed downhill.</li> </ul> </li> </ul>	<ul style="list-style-type: none"> <li>The location is on a sharp descent with sharp curves making it difficult for descending motorists to control their vehicles. Risk of loss of control therefore exists making it important to lower speed limits.</li> <li>To improve on visibility at night, streetlights have been provided to illuminate the section.</li> </ul>	<ul style="list-style-type: none"> <li>Installation of the missing directional arrow and hazard marker signs to warn motorists accordingly.</li> <li>Installation of speed limits and warning signs cautioning motorists to lower their approach speeds.</li> <li>Enforcement of speed regulations by relevant authorities.</li> <li>Installation of retro-reflective delineator road studs to mark lane extents.</li> <li>In the long term, consider widening the carriageway and provision of climbing lanes in light of the long and steep gradients.</li> </ul>

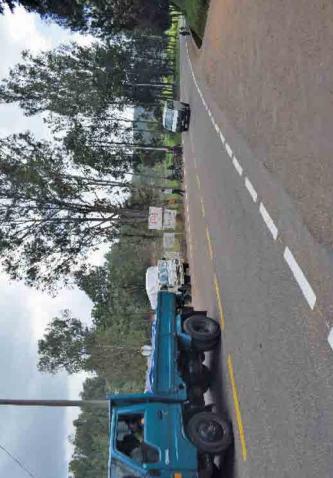
S/N	Name of the Spot	Chain-age (Km)	Survey Observations and Findings	Analysis/Diagnosis	Suggested Recommendation for improvement
10.	Byimana (Ntengyo)	64.5

<p>Irregular parking by motorcyclists on the shoulders to the main highway further reducing visibility splays at the cross junction.</p> <p>Narrow carriageway with no provision for NMT facilities.</p> <p>Lack of speed calming measures prompting motorists to drive downhill at high speeds.</p>	<ul style="list-style-type: none"> <li>The orientation of the cross junction is dangerous as minimum staggering distance has not been met.</li> </ul>	<ul style="list-style-type: none"> <li>Provision of speed limits and enforcement of speed regulations by relevant agencies</li> </ul>

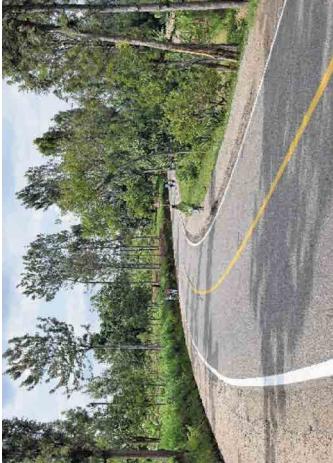
S/N	Name of the Spot	Chain-age (Km)	Survey Observations and Findings	Analysis/Diagnosis	Suggested Recommendation for improvement
11.	<b>Ngoma ('Umukobwa Mwiza Corner')</b>	122.2	<p>Lack of enhanced signage prohibiting motorists against overspeeding and overtaking</p>

<p><i>Skid off marks showing difficulties encountered by motorists in negotiating the curve</i></p>	<ul style="list-style-type: none"> <li>The location is on an extremely sharp horizontal curve especially for motorists approaching from the Akanyaru direction</li> <li>The road is narrow with insufficient provision for super elevation to counteract the centrifugal acceleration forces encountered by motorists.</li> <li>Faded road marking at the location might not be clearly visible at night.</li> <li>Insufficient speed calming measures on the approaches to the location.</li> </ul>	<ul style="list-style-type: none"> <li>Motorists and especially truckers tend to lose control and run off the carriageway due to increased centrifugal acceleration as they negotiate the tight curve. The area is characterized by multiple skid off marks indicating difficulties encountered by motorists in holding their vehicles within the carriageway.</li> <li>Redesigning of the horizontal curve to allow for sufficient super elevation and widening at the curve.</li> <li>Application of retro-reflective road marking to guide motorists accordingly especially at night.</li> <li>Installation of delineator road studs to mark the lane extents at night.</li> <li>Installation of rumble strips as a speed calming measure on both approaches to the curve.</li> <li>Clearing of the roadside vegetation to improve sight distances</li> </ul>

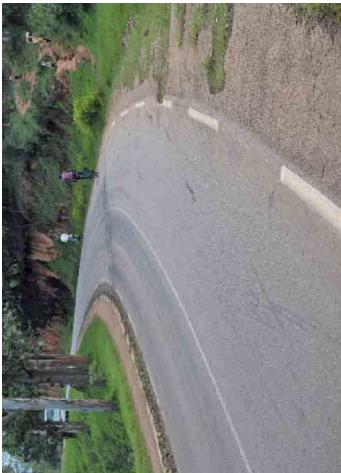
<p><i>Multiple skid off marks. Note the lack of super elevation at the tight horizontal curve</i></p>	<ul style="list-style-type: none"> <li>Roll over and head on collisions mostly fatal are common at the spot.</li> <li>'Danger' signs have been erected along the long descent to warn motorists.</li> </ul>	<ul style="list-style-type: none"> <li>In the long term, consider the following measures; <ul style="list-style-type: none"> <li>Widening of the carriageway and realignment of the section to allow for a more gentle curve.</li> <li>Consider provision of off-road truck run away ramps/arrester beds to cater for heavy vehicles that might lose control.</li> </ul> </li> </ul>

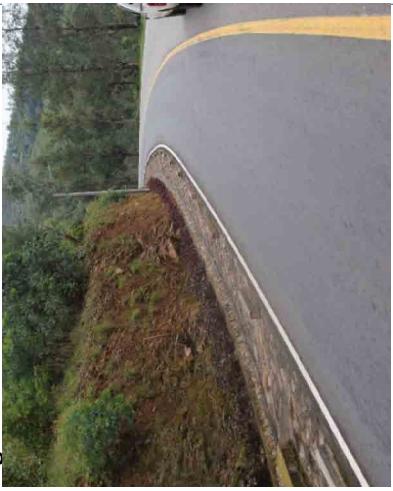
1.	<b>Kigali</b>

<p><b>National Road 2: Kigali - Musanze - Rubavu</b></p>	<ul style="list-style-type: none"> <li>The beginning of the NR2 from Kigali is characterized by a winding alignment ascending a hilly to mountainous terrain leading to successive combinations of horizontal and vertical curves. General observations include: <ul style="list-style-type: none"> <li>Lack of climbing lanes along the long and steep gradients creating significant small ups and safety hazards as ascending motorists try to overtake</li> </ul> </li> </ul>	<ul style="list-style-type: none"> <li>The road is 3.5m width,</li> <li>Consider provision of climbing lanes as the ultimate medium to long term solution.</li> <li>Provision of pedestrian walkways especially in the densely populated areas.</li> <li>Clearing of vegetation and protruding branches within the road reserve.</li> <li>Installation of more safety fences to secure the sharp curves on high and steep embankment.</li> <li>Installation of retro-reflective delineator road studs.</li> </ul>

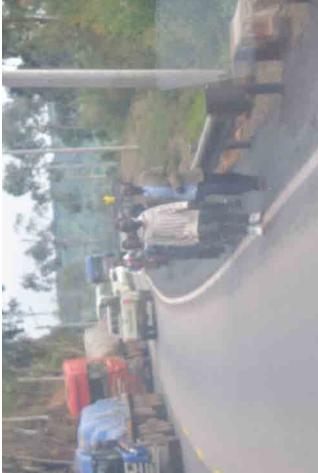
S/N	Name of the Spot	Chain-age (Km)	Survey Observations and Findings	Analysis/Diagnosis	Suggested Recommendation for improvement
1.	Rusiga	0-10

<ul style="list-style-type: none"> <li>Narrow carriageway with very sharp curves on steep embankment.</li> <li>Lack of a provision for NMT facilities causing pedestrians to walk precariously on the narrow shoulders</li> <li>Obstruction by vegetation and tree branches impairing sight distances.</li> <li>Missing delineator road studs to delineate the road.</li> <li>Inadequate warning signs.</li> </ul> <p><i>Lack of NMT facilities forcing pedestrians to walk on the carriageway shoulders</i></p>	<ul style="list-style-type: none"> <li>There is no enough clear zone.</li> <li>There is insufficient signage.</li> </ul>	<ul style="list-style-type: none"> <li>Installation of adequate warning signs cautioning road users on all the possible danger spots.</li> </ul>

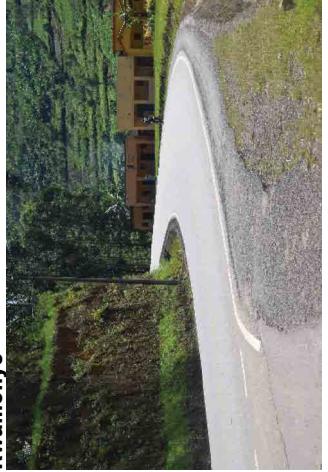
4.	<b>Rwamenyo</b>	45-47	<ul style="list-style-type: none"> <li>Lack of speed change lanes at the merger with the NR2 (Deceleration lane from the Kigali side and acceleration lane towards Musanze are missing)</li> </ul>	<ul style="list-style-type: none"> <li>Very sharp corner with a gentle descent from the Kigali side.</li> <li>Lack of adequate warning signage cautioning motorists on the sharp curve.</li> <li>Missing safety fences on the LHS to offer restraint vehicles that might lose control.</li> <li>Lack of adequate speed calming measures on the approaches to the hazardous spot.</li> </ul>	<ul style="list-style-type: none"> <li>Heavy goods vehicles manoeuvring the curve tend to lose control and topple over into the adjacent ditch.</li> </ul> <p><i>Dangerous sharp curve with little sight distance</i></p>

<ul style="list-style-type: none"> <li>Provision of speed limits and enforcement of speed regulations by relevant agencies.</li> <li>Installation of enhanced signage warning motorists of the dangerous curve.</li> <li>Installation of flex beam guardrails on the LHS (preferably with reflective studs on the inner side) to offer restraint in the event of an emergency.</li> <li>Consider provision of rumble strips as speed calming measures on the approaches</li> <li>Repair of the deteriorating shoulder edges to safeguard the pavement's design life</li> </ul>

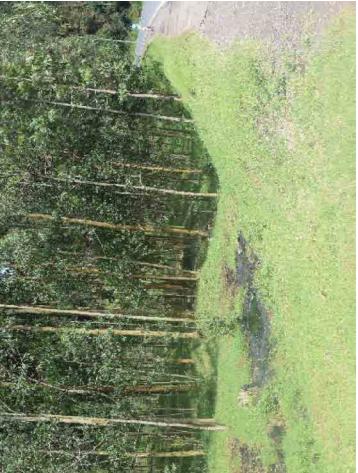
S/N	Name of the Spot	Chain-age (Km)	Survey Observations and Findings	Analysis/Diagnosis	Suggested Recommendation for improvement
5.	Buranga-Musanze section	54-64

<p>• Damaged road shoulders/ deteriorating pavement edges.</p> <p><i>Evidence of a recent run-off collision</i></p>	<p>Pedestrians walking on or near the road edges are exposed to vehicular traffic making them prone to vehicle-pedestrian collisions</p> <p>The densely populated area has a high population of pedestrians mainly accessing the nearby market. Road safety concerns identified include:</p> <ul style="list-style-type: none"> <li>Narrow carriageway (3.5m lane width) with no provision of NMT facilities. Pedestrians are forced to walk on or near the road edge as a result.</li> <li>Open side drains too close to the road edges.</li> <li>Deteriorating shoulders leaving rugged shoulder edges.</li> <li>Missing delineator road studs to guide motorists along the centre at night.</li> </ul> <p><i>Pedestrians walking on the road edges due to lack of NMT facilities</i></p>	<p>In the long term, consider the following:</p> <ul style="list-style-type: none"> <li>• Widening of the carriageway and re-designing of the section to allow for a more gentle curve with sufficient super elevation</li> <li>• Construction of an off-road truck run-away ramp/arrester bed for emergency use by heavy vehicles that might lose control.</li> </ul> <p>Consider 2m shoulders) and provision of separate NMT facilities along the center i.e. pedestrian walkways, designated pedestrian crossings etc.</p> <p>Covering the open drains that are too close to the carriageway or reducing the gradient of their slopes</p> <ul style="list-style-type: none"> <li>• Repair of the damaged shoulder edges</li> <li>• Installation of delineator road studs to mark the lane extents at night</li> <li>• Provision of standard sized bus bays to allow for safe stops</li> </ul>

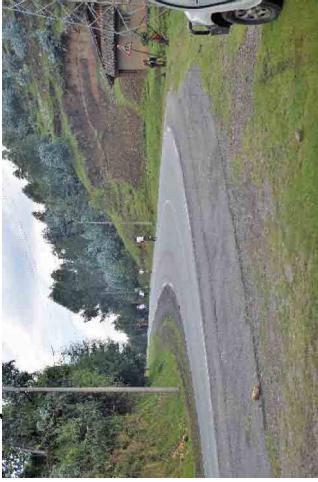
S/N	Name of the Spot	Chain-age (Km)	Survey Observations and Findings	Analysis/Diagnosis	Suggested Recommendation for improvement
6.	<b>Bwanju Corner</b>	99.2	<ul style="list-style-type: none"> <li>• Sharp horizontal curve combined with a gentle vertical curve</li> <li>• Missing warning signs to caution motorists on the sharp curve</li> <li>• Fading road marking (No yellow centreline marking).</li> <li>• Missing delineator road studs to guide motorists at night.</li> </ul>

<ul style="list-style-type: none"> <li>• Most crashes at this location are run-off and are mainly prevalent during the night.</li> <li>• Despite the spot being illuminated by streetlights, more interventions are still required to make the spot safer.</li> </ul>	<ul style="list-style-type: none"> <li>• Installation of directional arrow signs on the outer edge of the curve to warn motorists on sharp change of direction.</li> <li>• Installation of road signage warning motorists of the dangerous curve ahead and prohibiting overtaking at blind corners.</li> <li>• Installation of retro-reflective delineator road studs especially on the outer lane edges.</li> <li>• Application of retro-reflective road marking to replace the fading one (consider using yellow paint for the centerline to harmonize the road network)</li> </ul>

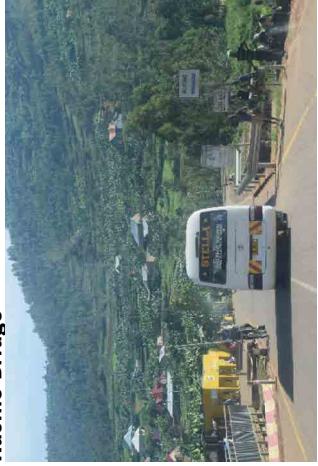
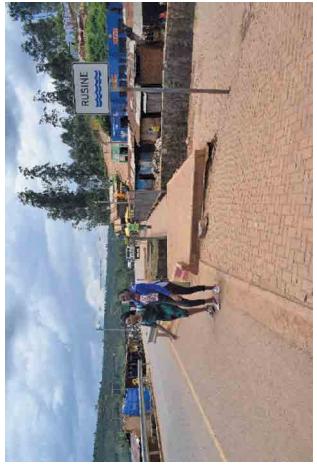
2.	Rusine Bridge	30.4	<p>The narrow bridge lacks sufficient restraints with the provided tapes and cones being inadequate</p> <ul style="list-style-type: none"> <li>The narrowed bridge (6m width) lacks parapets on either side; the LHS guardrails are completely missing</li> <li>Missing safety fences on the approaches to the bridge leaving gapping open windows</li> <li>Missing hazard marker signs at the bridge and warning signs to caution motorists on the narrow bridge</li> <li>The pedestrian footbridge is unfriendly to the elderly and Persons With Disability (PWDs) as it lacks a ramp to join it to the surface level</li> </ul>

<p>The narrow bridge is a safety hazard as motorists are forced to pass through a constricted roadway.</p> <ul style="list-style-type: none"> <li>Head on and side swipe collisions are likely as a result</li> <li>In the medium to long term, consider:           <ul style="list-style-type: none"> <li>Expansion/widening the bridge with a sufficient provision for pedestrians on either side</li> <li>Provision of parapets to the newly constructed bridge to offer restraint in the event of an emergency.</li> </ul> </li> </ul>

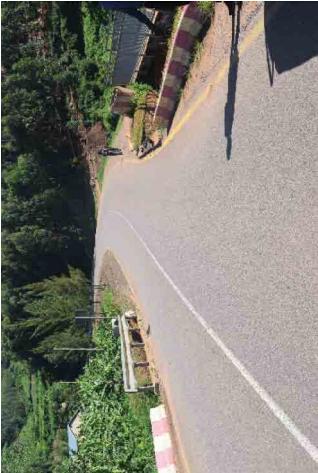
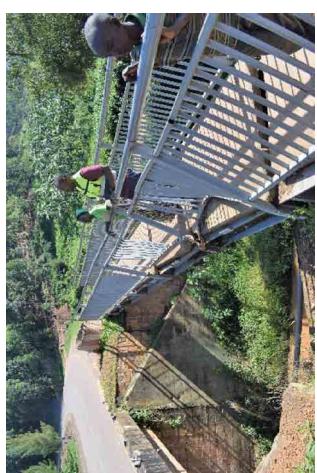
S/N	Name of the Spot	Survey Observations and Findings	Analysis/Diagnosis	Suggested Recommendation for improvement
3.	<b>Musenyi (digiri Bridge)</b>	<p>• Two sharp combinations of horizontal and vertical alignments converge into a narrow bridge which has already been structurally compromised by previous crashes</p> <p>• The narrowed bridge (6m width) has damaged guardrails on either side; the LHS guardrail is completely missing</p> <p>• The bridge parapets are too short to offer any significant restraint in case of an emergency</p> <p>• Missing safety fences on the approaches to the bridge leaving gapping open windows</p> <p>• Missing hazard marker signs at the bridge and warning signs to caution motorists on the narrow bridge</p> <p>• Damaged pedestrian footbridge on the RHS; it presents a safety hazard as it might cave in at any time</p>

<ul style="list-style-type: none"> <li>The narrow bridge with insufficient safe stopping sight distance at the convergence of two winding terrains creates a hazard to motorists. The problem is further exacerbated by damaged/missing parapets and safety fences.</li> <li>Collapsed pedestrian bridge is a safety hazard to the pedestrians</li> </ul>	<ul style="list-style-type: none"> <li>As an immediate intervention, there is need for installation of safety guardrails on the bridge and repair of pedestrian footbridge</li> <li>Installation of hazard marker signs on the bridge and warning signs on the narrow bridge from either approaches</li> <li>Installation of delineator road studs to show the extents of the bridge at night</li> </ul> <p>In the medium to long term, consider:</p> <ul style="list-style-type: none"> <li>Expansion/widening the bridge with a sufficient provision for pedestrians on either side and realignment of the section to eliminate the sharp curves</li> <li>Provision of parapets to the newly constructed bridge to offer restraint in the event of an emergency.</li> </ul>

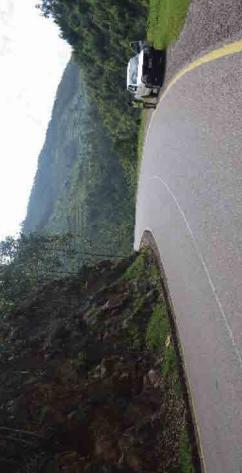
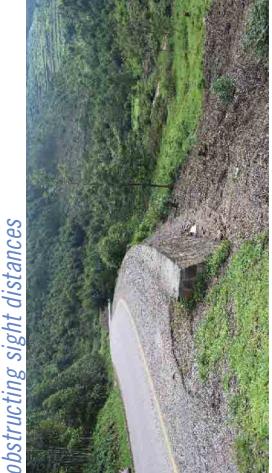
S/N	Name of the Spot	Chain-age (Km)	Survey Observations and Findings	Analysis/Diagnosis	Suggested Recommendation for improvement
4.	<b>Rwafandi Corner</b>	32.9	<ul style="list-style-type: none"> <li>The corner is on a successive combination of sharp horizontal curves and has a huge boulder obstructing sight distance for motorists</li> <li>Missing safety fences on the LHS</li> <li>Lack of warning signs on the approaches as well as directional arrow signs to warn motorists on the sharp change of direction</li> <li>Vehicles negotiating the curve tend to drive on the middle of the road for fear of toppling over due to centrifugal forces</li> </ul> <p><i>Very sharp curve with a huge rock outcrop obstructing sight distances</i></p>

<p>Steep and winding terrains without safety guardrails can lead to unforgiving crashes should they occur.</p>	<ul style="list-style-type: none"> <li>Provision of safety fences on the LHS of the curve to restrain errant motorists in case of loss of control</li> <li>Installation of directional arrow signs to warn motorists on the sharp change of direction</li> <li>Installation of warning signs on the approaches to the sharp corner</li> <li>In the long term, consider redesigning of the section to eliminate the sharp curve and further provide sufficient widening at the curves</li> </ul>

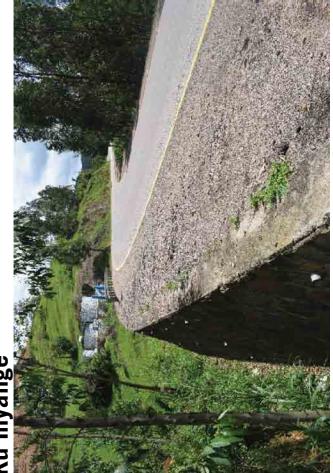
5.	<b>Ku Inyange</b>			<p>The hazardous spot is on a descent from Gatuna towards Kigali</p> <ul style="list-style-type: none"> <li>Damaged safety fences on the sharp curve leaving a dangerous open window</li> <li>Lack of directional arrow signs to guide motorists</li> </ul>	<ul style="list-style-type: none"> <li>Replacement of the knocked off safety fences (consider flex beam guardrails with reflective studs on the inner side)</li> <li>Installation of directional arrow signs to guide motorists through the sharp curve</li> <li>Installation of warning signage on the successive sharp curve ahead and informative signage cautioning motorists to drive on low gear</li> </ul> <p><i>Missing safety fences on the LHS</i></p>

<p><i>Sharp curve with knocked off safety fences on high embankment</i></p>

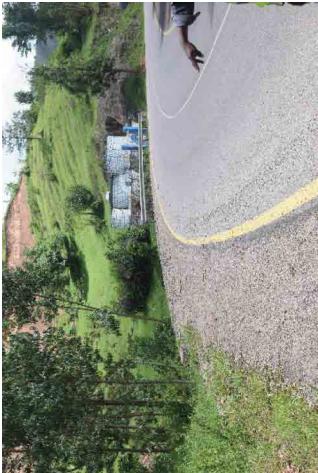
S/N	Name of the Spot	Chain-age (Km)	Survey Observations and Findings	Analysis/Diagnosis	Suggested Recommendation for improvement
5.		44.1	<ul style="list-style-type: none"> <li>Dangerous termination of the existing guardrail section; The dangerously exposed ends might pierce onto oncoming traffic upon impact</li> <li>Lack of proper warning signage cautioning motorists on the sharp curve</li> </ul>

<ul style="list-style-type: none"> <li>Installation of fishtail end pieces on the dangerously exposed guardrail section to buffer motorists upon impact</li> <li>Installation of delineator retro-reflective studs to mark the lane extents</li> </ul>

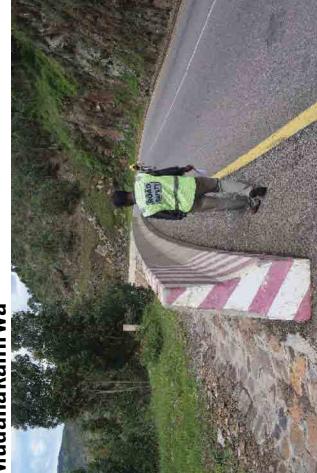
6.	<b>Mudahakanira</b>	44-48	<ul style="list-style-type: none"> <li>The road winds through a hilly terrain and is on high embankment for majority of the stretch.</li> <li>The section is well guarded with 1.2m high reinforced concrete barriers. They are however not painted with reflective paint</li> <li>Safety fences are however missing on some sections on high embankment</li> <li>The sharp curves lack directional arrow signs to warn motorists</li> </ul>

<p>The high embankment has been secured with concrete crash barriers for most of the stretch</p>	<ul style="list-style-type: none"> <li>Consider extending the crash barriers to cover all the curves on high embankment</li> <li>Installation of reflective tapes on the barriers/ painting them with retro-reflective paint</li> <li>Installation of directional arrow signs to guide motorists through the sharp curves</li> <li>Installation of delineator retro-reflective studs to mark the lane extents of way.</li> </ul>
